Introduction

The survey aimed to repeat a survey of key sites where sediment was found to enter the River Wensum catchment, undertaken in 2010 by APEM Aquatic Scientists for the Environment Agency, which included the River Wensum amongst other English rivers identified as the top failing salmon catchments in England where fine sediment is a known problem.

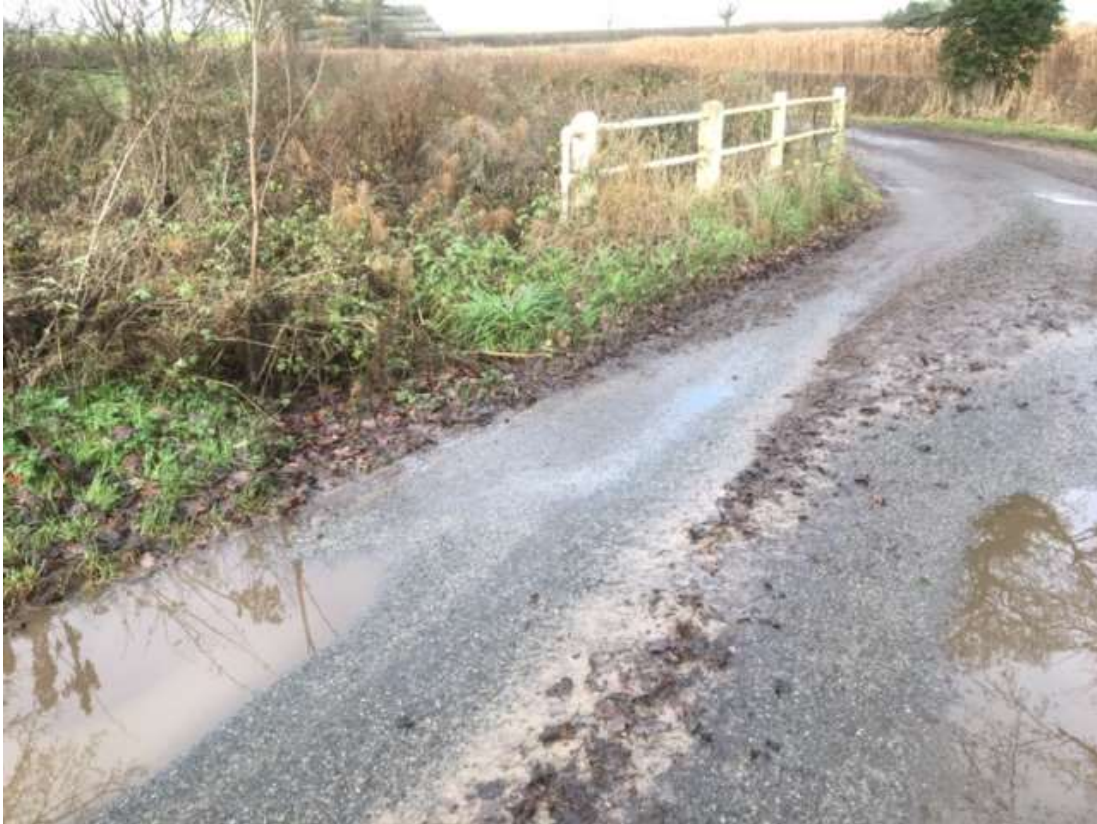
76 Reepham TG0753523966 (*Road and arable runoff*) (TE)
Forwater Road, east of Reepham, north of Brick Kiln Farm

Physical site appears unchanged where road runoff enters beck near bridge, via channels cut for drainage.

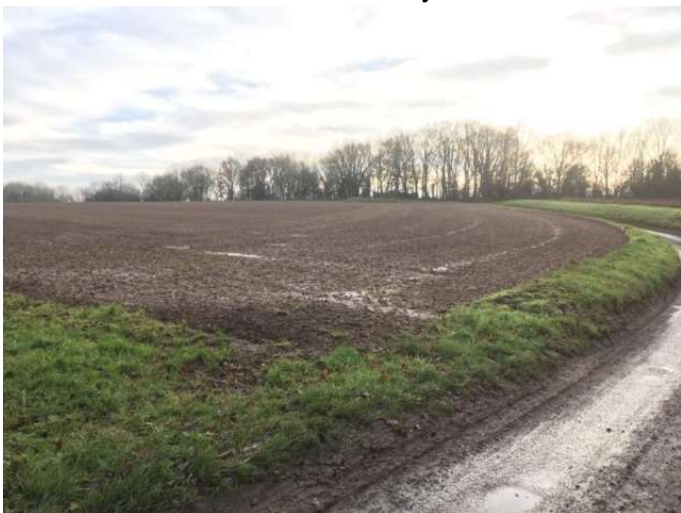
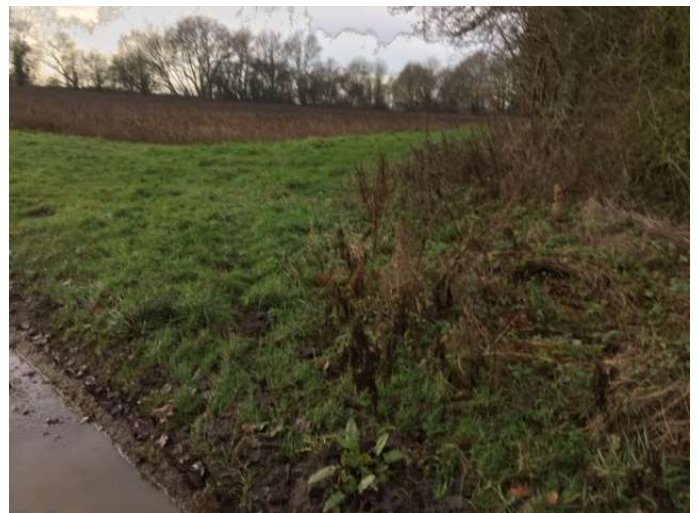
Arable fields in immediate vicinity now have buffer strips.

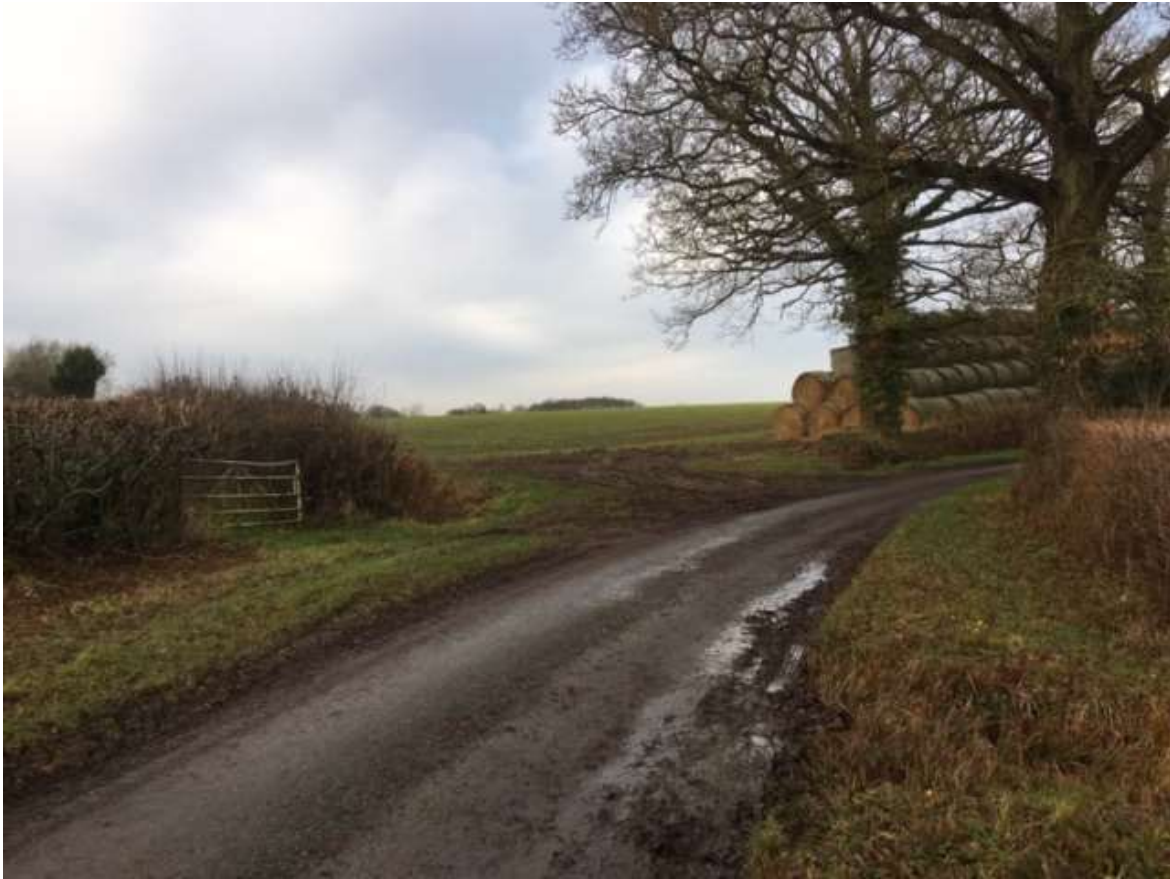
However a field gateway a short distance to the north and uphill appears to be contributing significant amounts of sediment, which is being carried down to the bridge area.

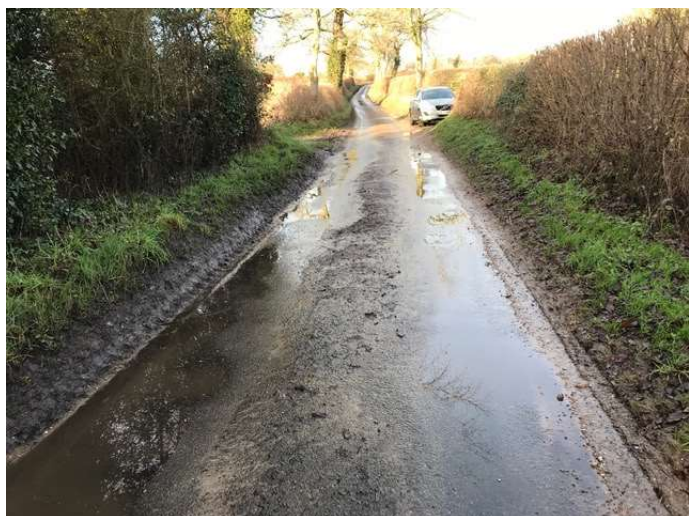
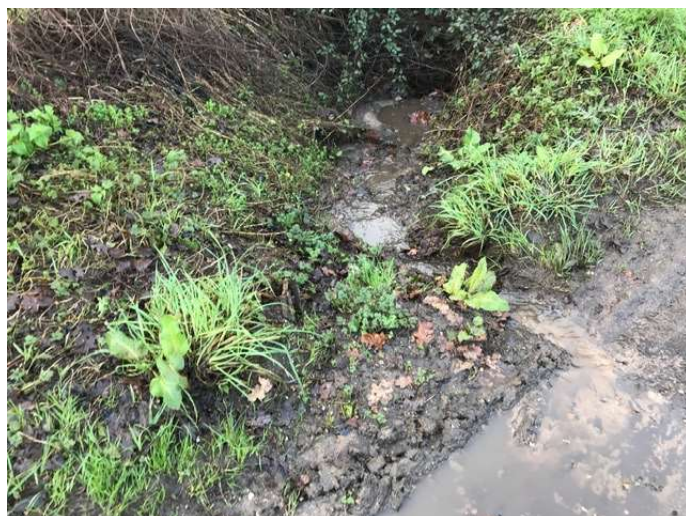
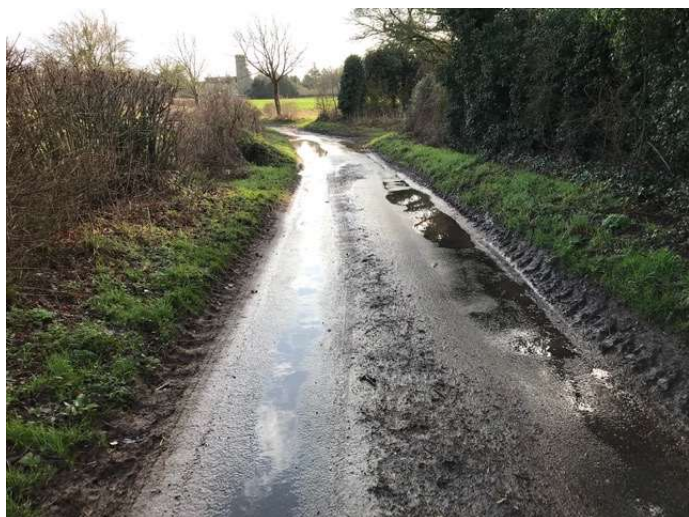
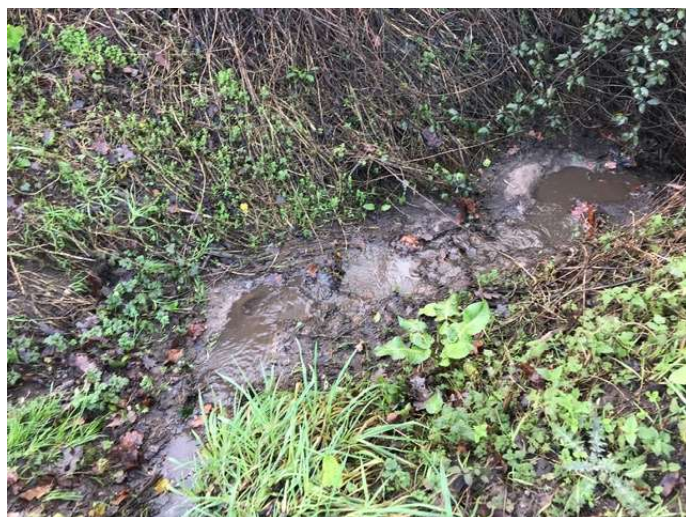
381 Reepham TG1019520360 (Road runoff) (CH)
Location – nr Gt Witchingham church.

Plenty of runoff from both sides of the small valley, silt building up on road sides then washed down, flows into beck from both sides, several gateways in area with medium concentration.

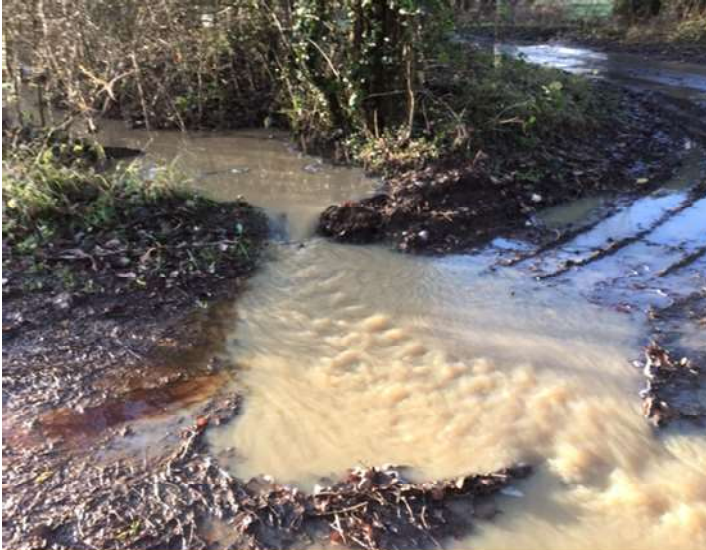
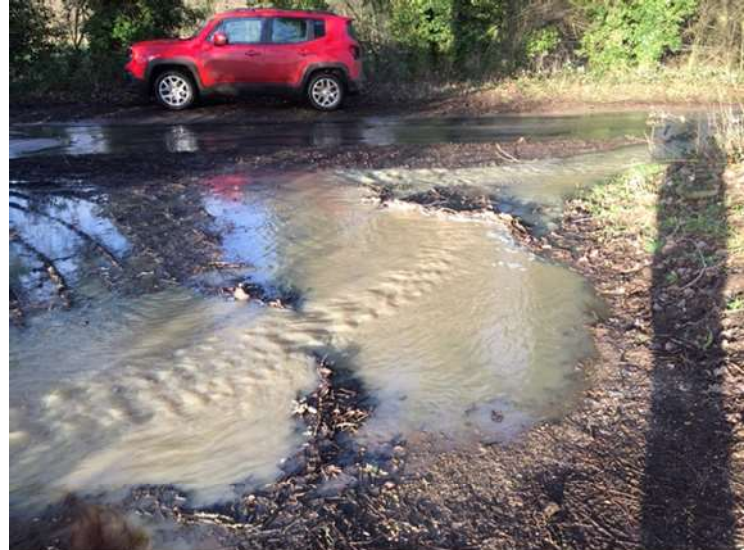
Lane near Blackwater Farm

Turbid water overflowing from end of ditch onto road. This includes run-off from fields and an extensive stableyard.

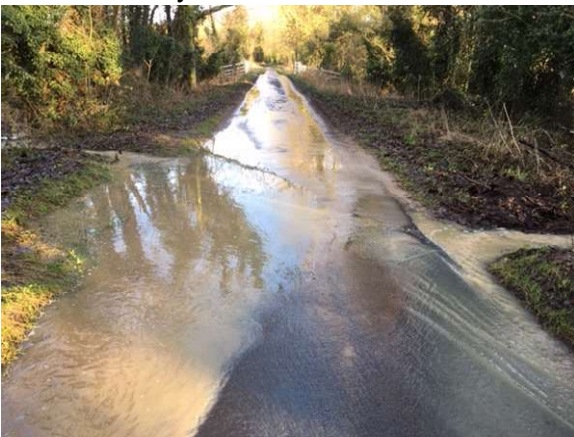
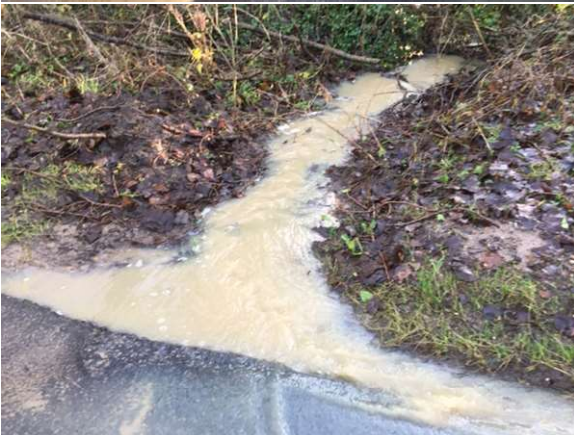
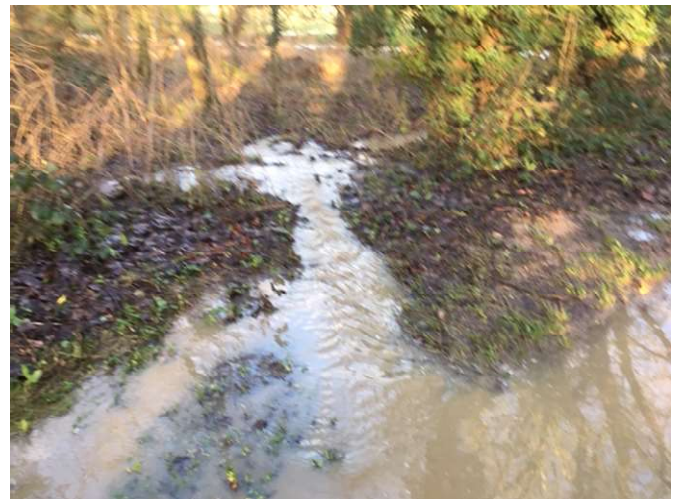
Then running down road towards small bridge over the Blackwater, before flowing off on either side and thence directly into the river.

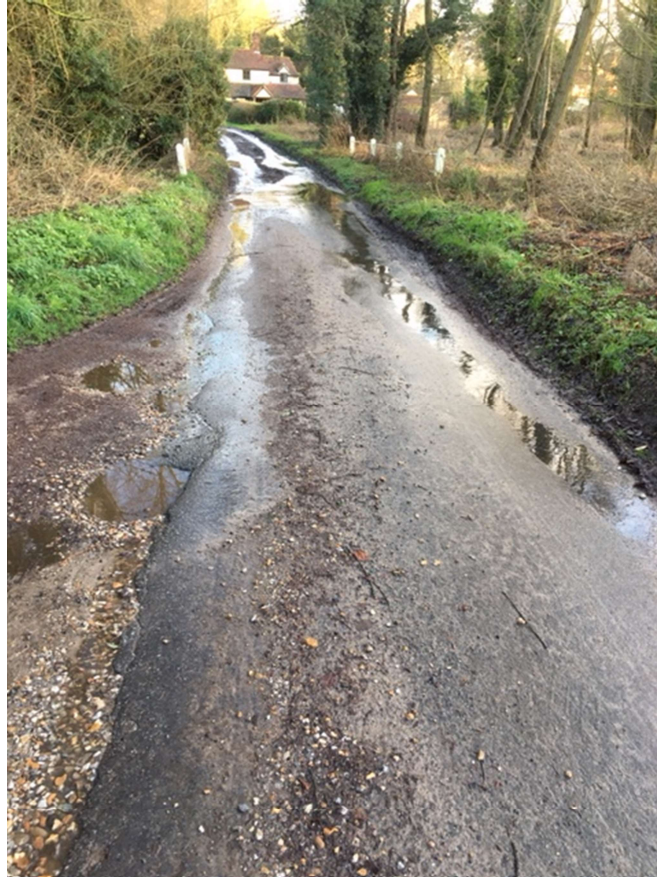
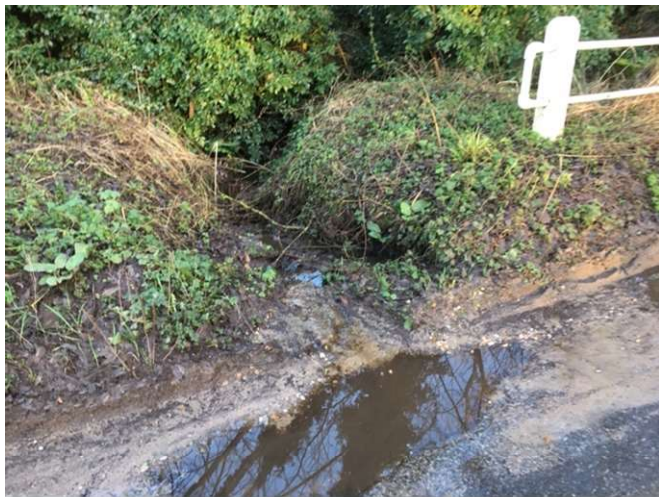
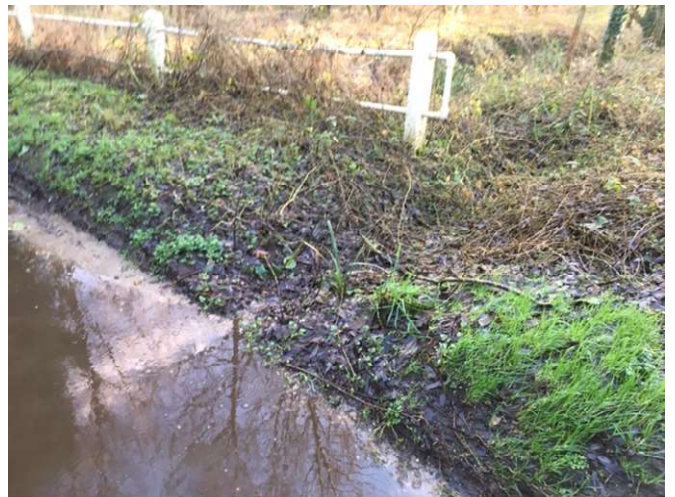
Ketts Lane, Swannington

Section of road approaching bridge over a small stream, which appears to be a minor tributary of the Wensum. Silt, sand and gravel evident on road, with water travelling downhill from various gateways before entering the stream via gulleys in the verge.

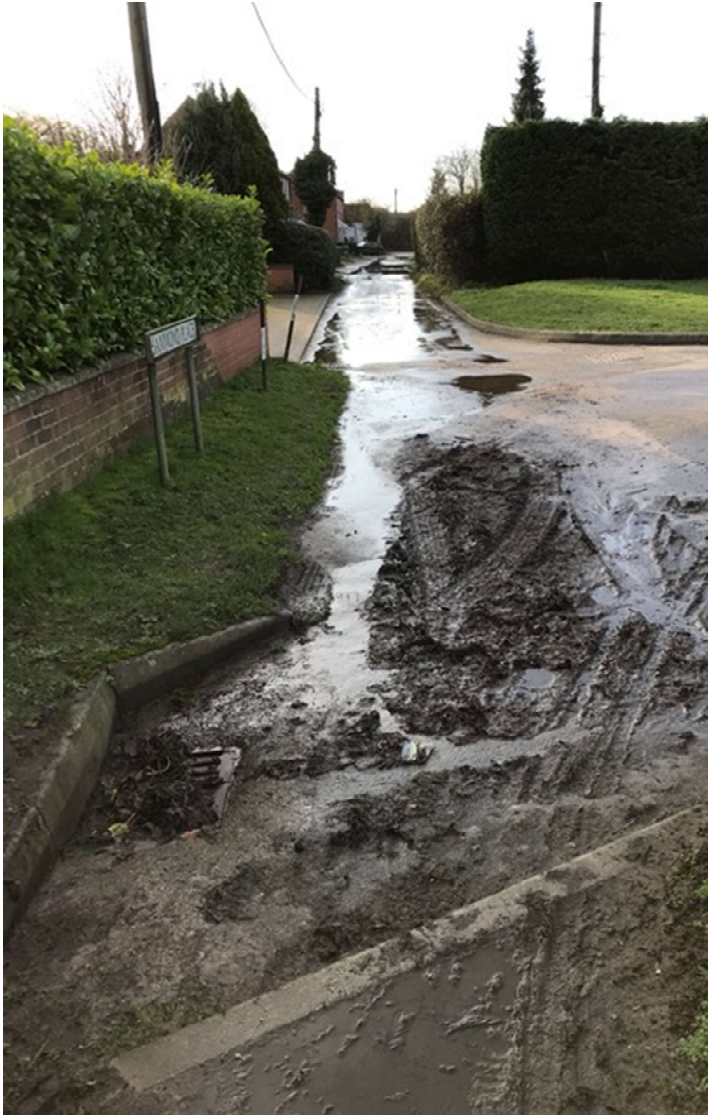
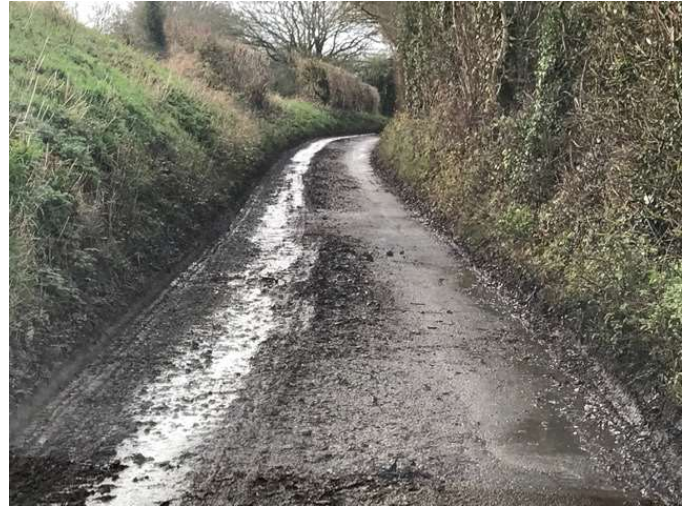
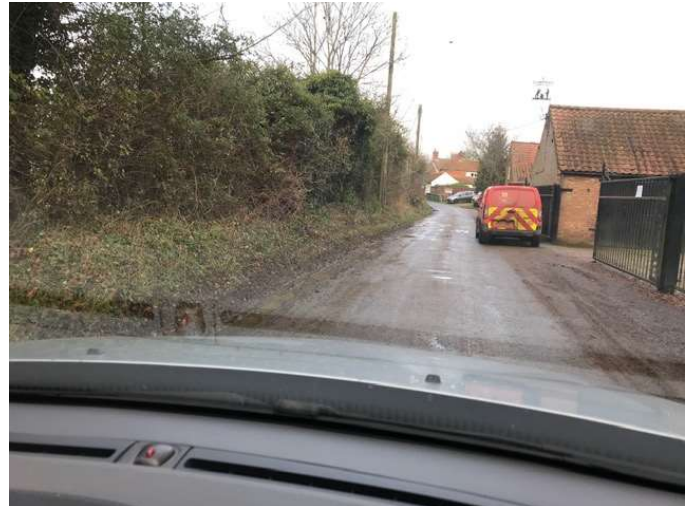
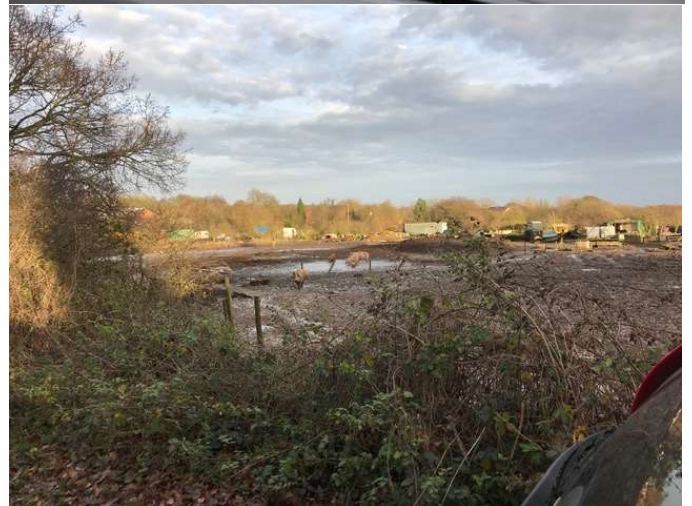
99 Main River Wensum, Caddes Hill, Lyng (CH)
(not grade 1 site in APEM survey, but included as possible site for silt trap)

Lyng Caddes Hill and surrounding area, all silt from pig farm and Caddes Hill filters to main picture which is in Back Lane. Then into drain and ditch which connects to IDB drains which connect to main river.
Other roads feed to same ditch system in rectory road.

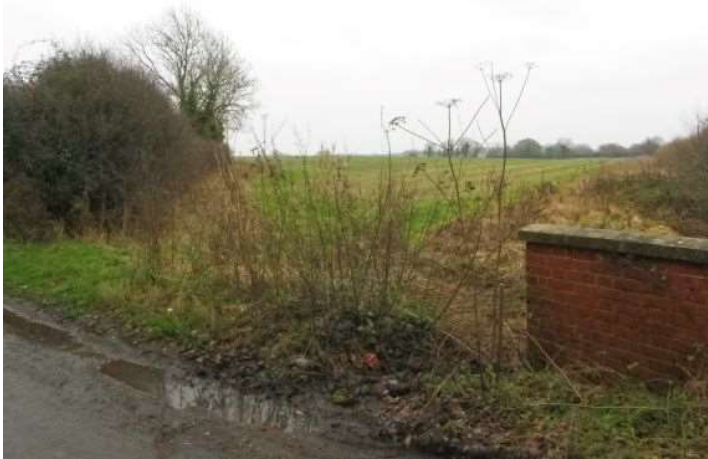
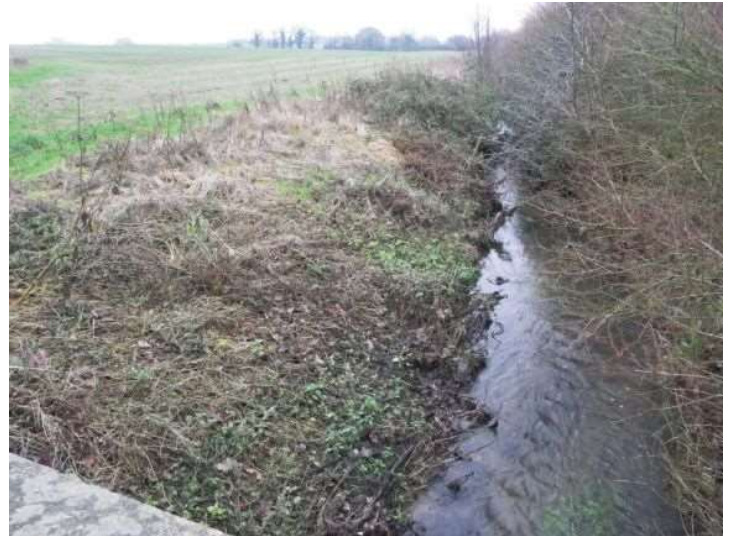
307 Foulsham TG0221230583 (*Arable runoff*)
Road bridge on Hindolveston-Foulsham Rd, S of Hindolveston

2010 survey photo is looking downstream from bridge at L bank – photo (left) from same position:

L bank downstream is still arable, stubble at present but will be ploughed at some time. Rough margin next to river will help to prevent some direct silt run-off (photo, right).

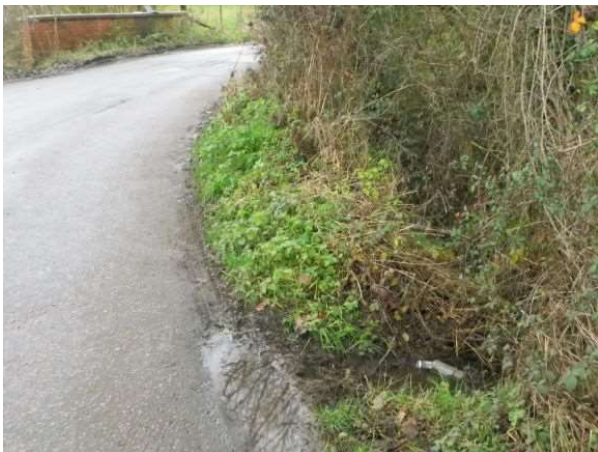
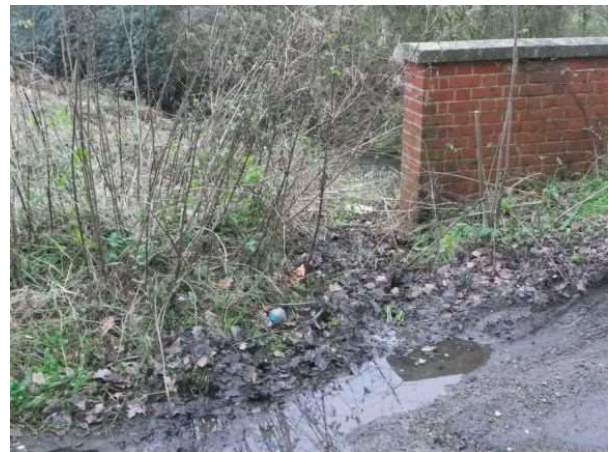
Gullies in road verge run directly into stream or via short ditch:

Potential silting issues still likely.

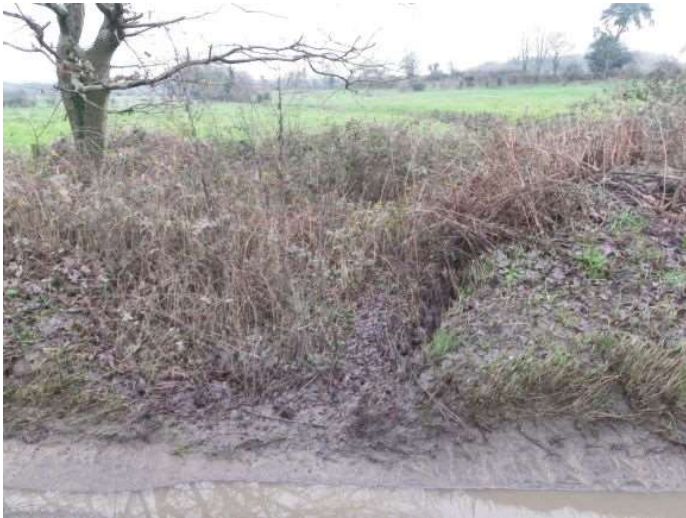
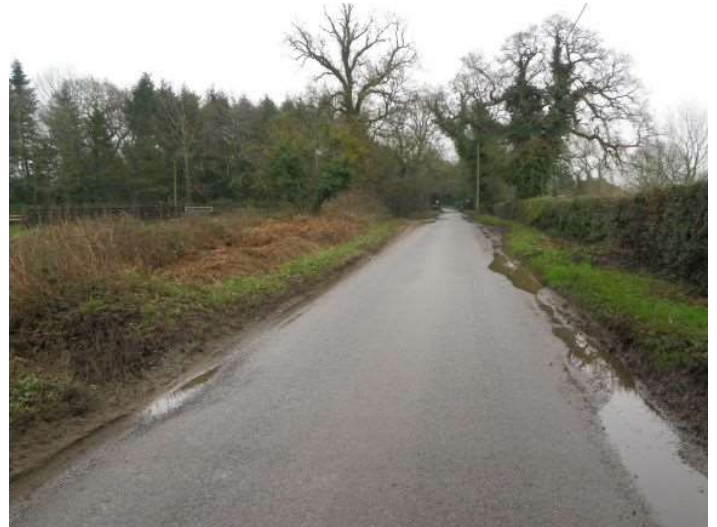
324 Foulsham 6 TG0367727145 (Road runoff and poaching)

2010 survey photo is on N side of road (left, below), W of where stream crosses.

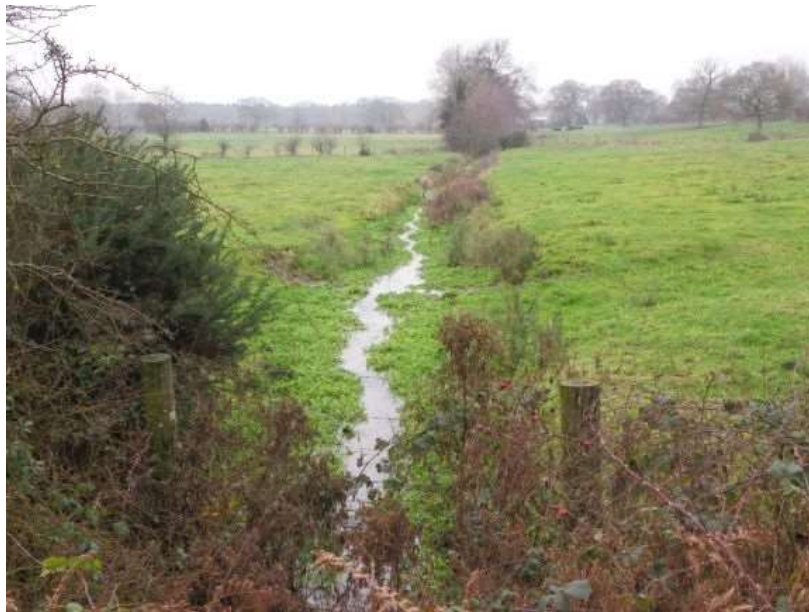
There are other gullies off the road on both sides, deeper on N side but it appears that most run-off from road will occur on S side because of camber, where gullies run into field, not a ditch:

Cattle drink area immediately downstream of road but little poaching at present and no sign of vehicles crossing. No sign of poaching upstream from road (photo above) but some cattle in field next to river further upstream.

Looks unlikely to generate significant sediment at present, but could do if road drainage gullies and ditches re-excavated.

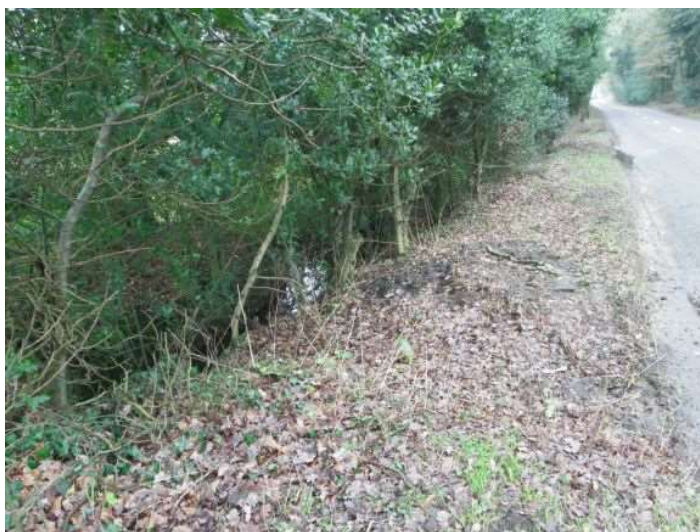
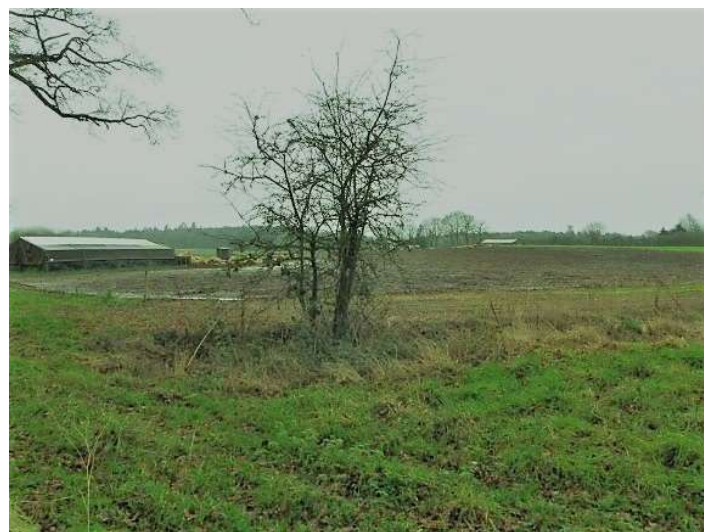
329 Foulsham 7 TG0235629619 (Earth mound, field runoff and ford)
E off B1110, S of Swanton Novers

Stream culverted under B1110 S of Swanton Novers, then runs parallel to road for short distance with gullies on E side of road running directly into it (phot, left).
Gullies on W side of road run into ditch, which presumably also joins stream. Farm track joins road nearby – potential silt source.
After stream leaves road, it runs past outdoor pigs on L bank – lot of bare ground, with small grass margin (about 5m?) separating it from stream (photo, right).

Site 329 in 2010 survey appears to be just downstream from here.
Still looks likely to be significant silting issues in this location.

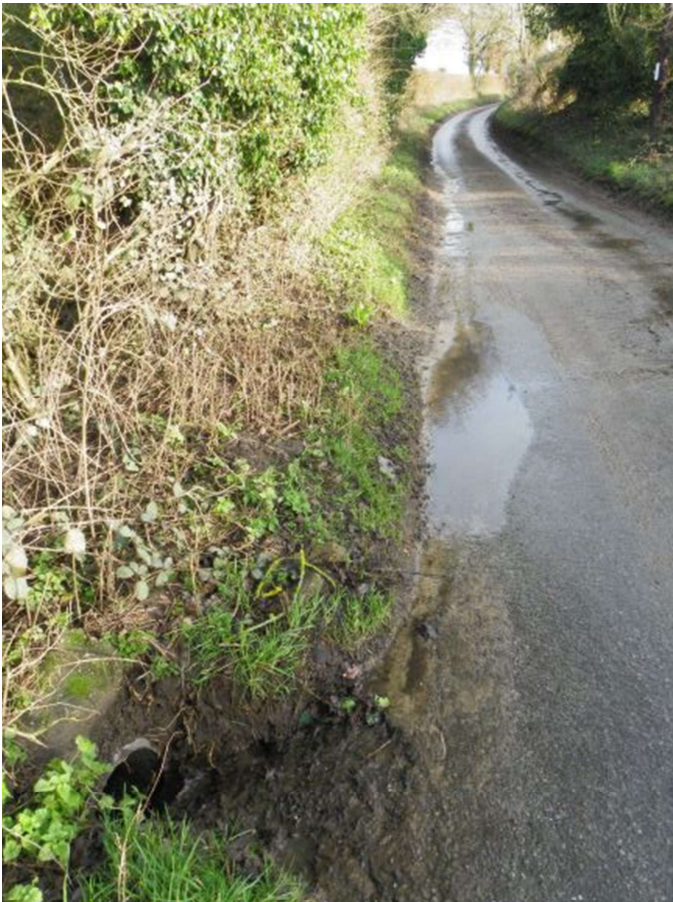
Potential road run-off point identified on minor road crossing feeder west of Wood Norton (photo, left)

Slope on both sides of crossing, road with mud from farm vehicles, run-off directly into feeder via pipe on both sides of road.

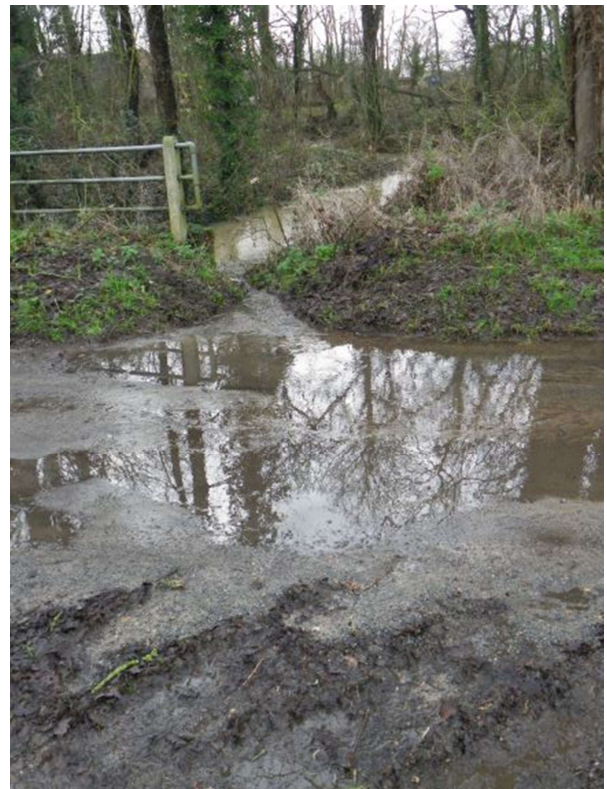
Photo (right) shows mud on minor road where it crosses feeder at Pockthorpe, south-east of Foulsham, and run-off into heavily coloured feeder.

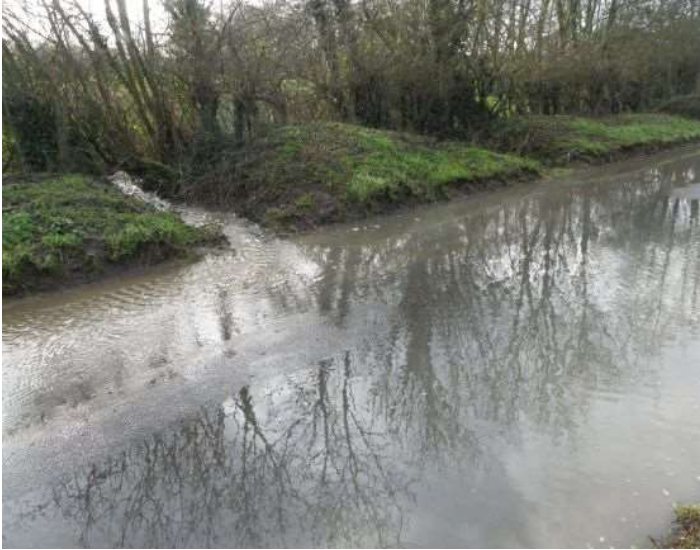
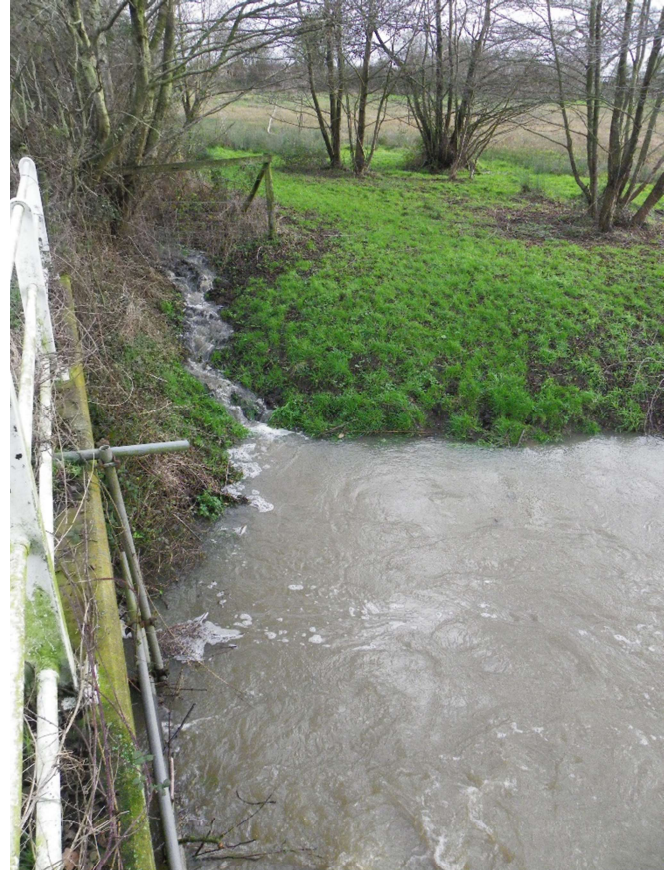
Minor road crossing east of Foulsham, on Foulsham-Themelthorpe road – flooded road with mud from agricultural vehicles, sediment-rich water entering river via gulleys

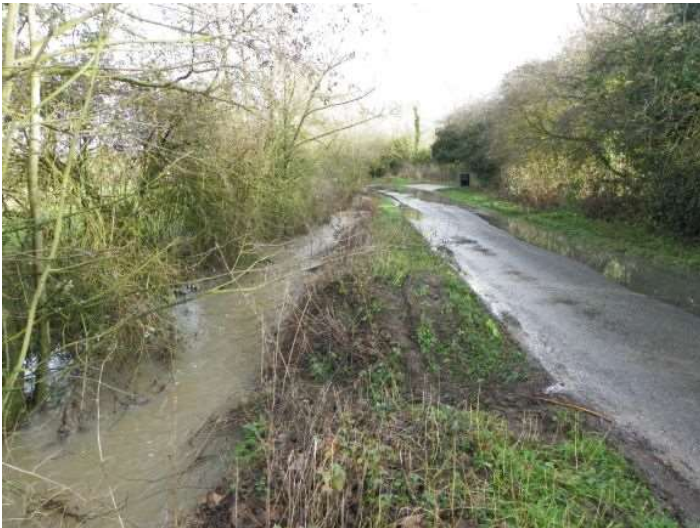
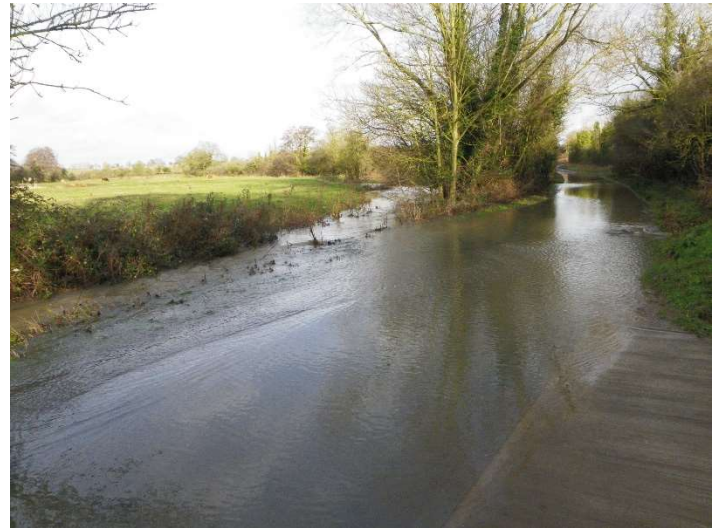
At Bates Moor Farm, next minor road crossing upstream, stream runs alongside road for a short stretch and was flooding across muddy road.

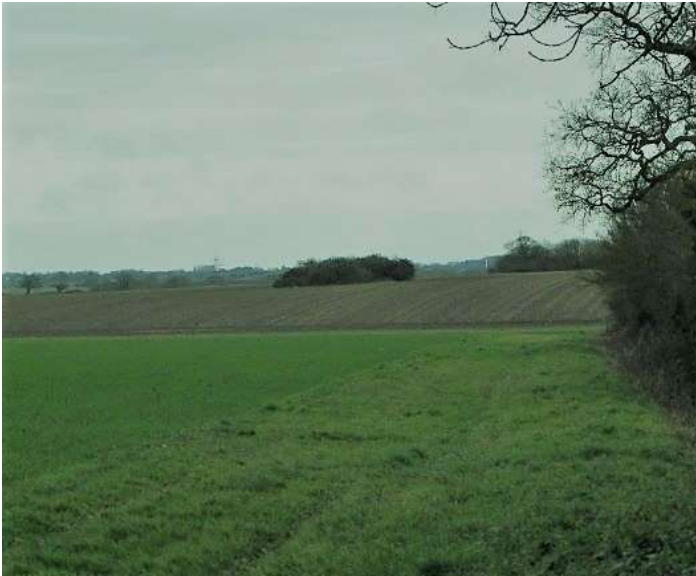
112 Wensum West TF8821022770 (*Arable runoff*)
Minor tributary nr Wellingham

Unable to see if ditch has been re-excavated recently, but still arable fields both sides with potential for sediment run-off.

Photo (left) from adjacent minor road off A1065 shows bare arable field on R bank, arable short crop on L bank, beck in break between two.

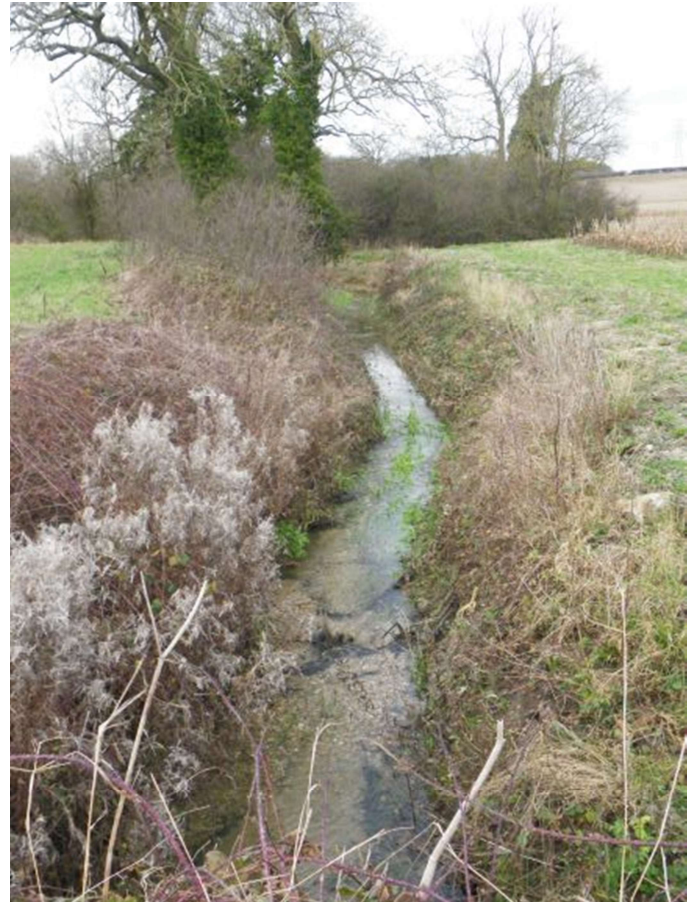
Photo (right) is downstream where beck goes under minor road from West Raynham to Whissonsett. Some steeply cut areas of unvegetated bank but bed is mainly gravel.

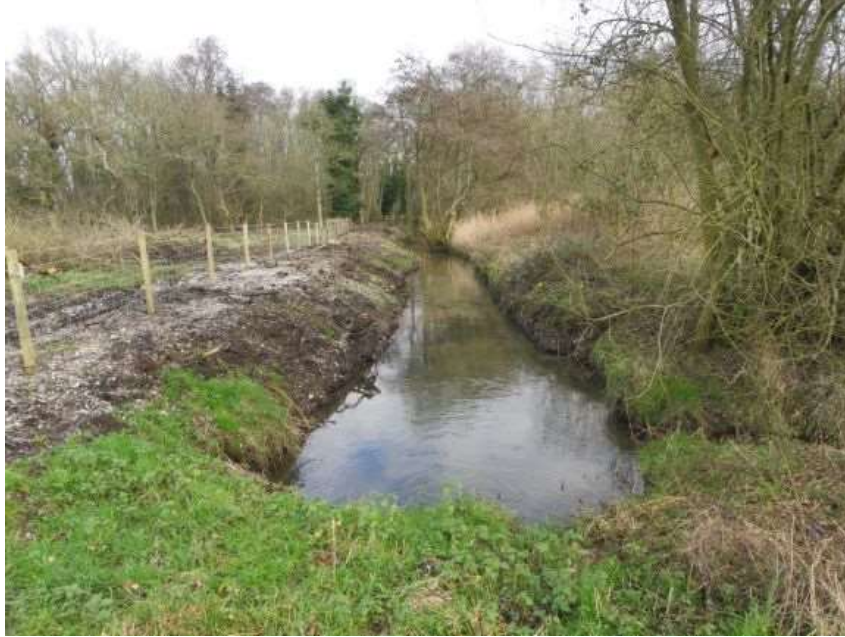
101 Wensum West TF8803124056 (*Bank clearance and straightening*)

Site appears to be where footpath running S from near South Raynham church crosses beck:

Channel recently dredged and widened, with steep and unconsolidated banks, dredged material on banks likely to wash back in, sediment in channel. New fencing recently erected.

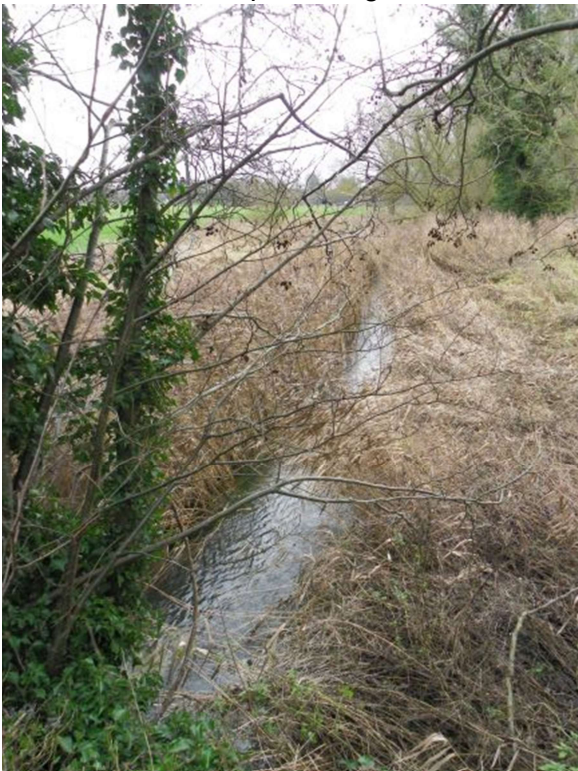
265 Wensum TF8752025985 (*Bank clearance*)

Photo u/s from footpath bridge:

Significant silt in channel u/s of footpath bridge, but no sign of any recent work on banks from here or bridge on minor road near church to S. Report also mentions "Bare unconsolidated silty topsoil is found periodically on both banks for approximately 750m upstream of the start NGR. These fine sediment sources are a product of recent hay cutting." Hard to see how hay cutting would generate significant sediment!

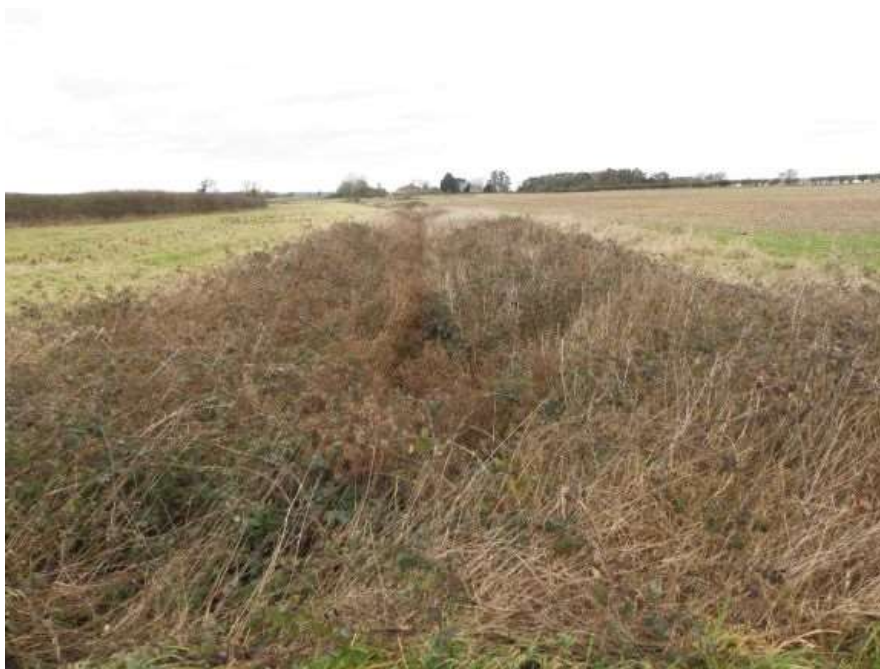
283 Great Ryburgh TF9376626018 (*Resectioned bank*)

L bank is rough grassland, R bank arable with narrow uncultivated margin. Ditch overgrown, no sign of recent work.

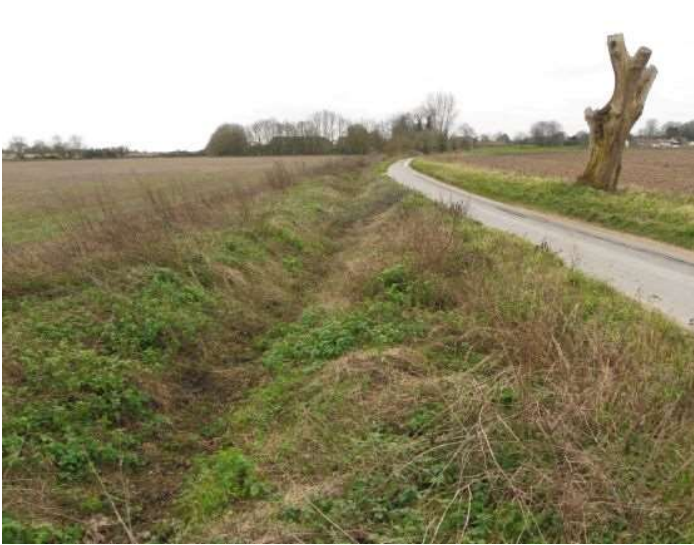
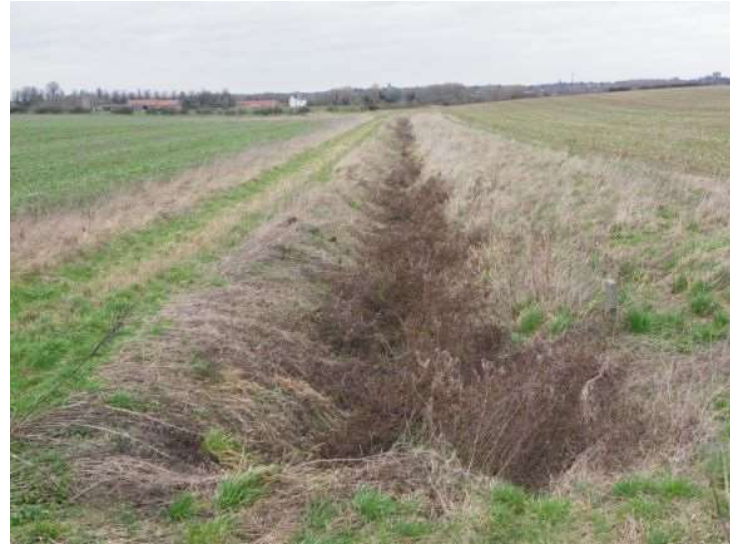
136 Racecourse tributary TF9259927024 (*Arable field drain*)

Ditch is now completely vegetated and barely visible (photo, left).

Ditch is culverted under B1146 and this road and Gt Ryburgh road, photo (right) below shows it to N of latter – again vegetated, no recent maintenance but with only narrow margins to arable fields on both banks:

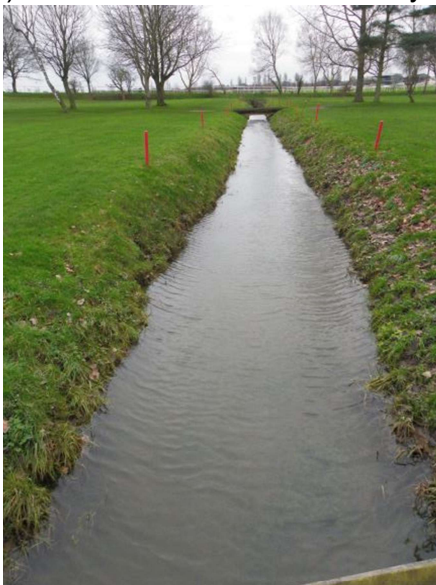
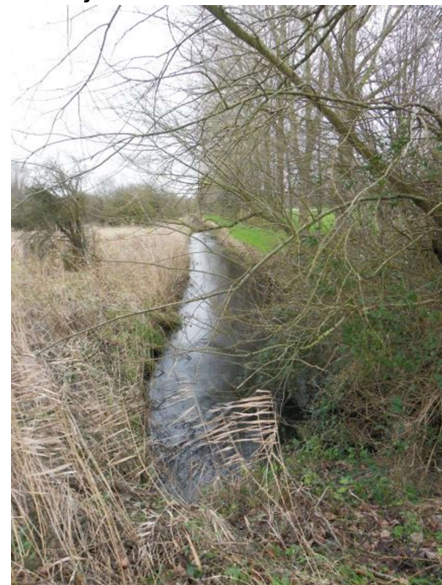
Also looked at where, after E and W arms join S of Fakenham racecourse, the racecourse tributary joins another tributary running parallel to main river alongside Fakenham golf course ('golf course tributary'). Photo (left) shows the racecourse tributary (u/s) just before the junction.

Photo (right) shows the golf course tributary looking d/s from the access road to Fakenham Sports Centre / racecourse.

Golf course tributary is widened and very silty but no sign of recent maintenance. Racecourse tributary was rather murky, although no rain for last few days, with silt in the channel.

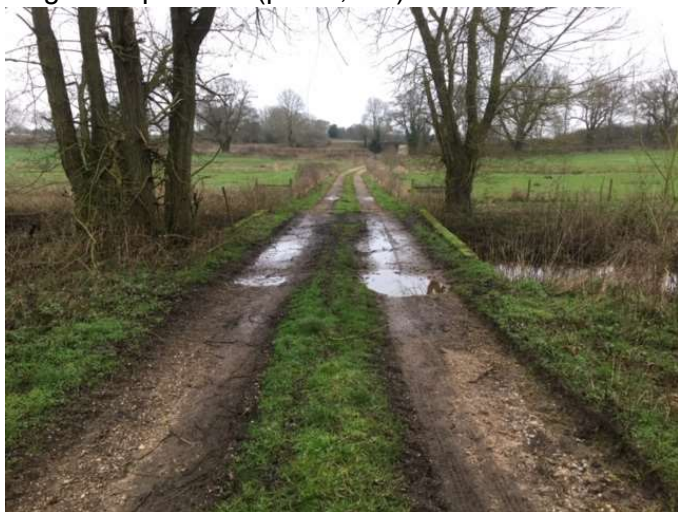
30 Blackwater main stem TF9898618419
Track east off Hoe Road, south of Worthing

The bridge area is now much less affected by sediment, sand, gravel etc since the gravel workings are no longer in operation (photo, left).

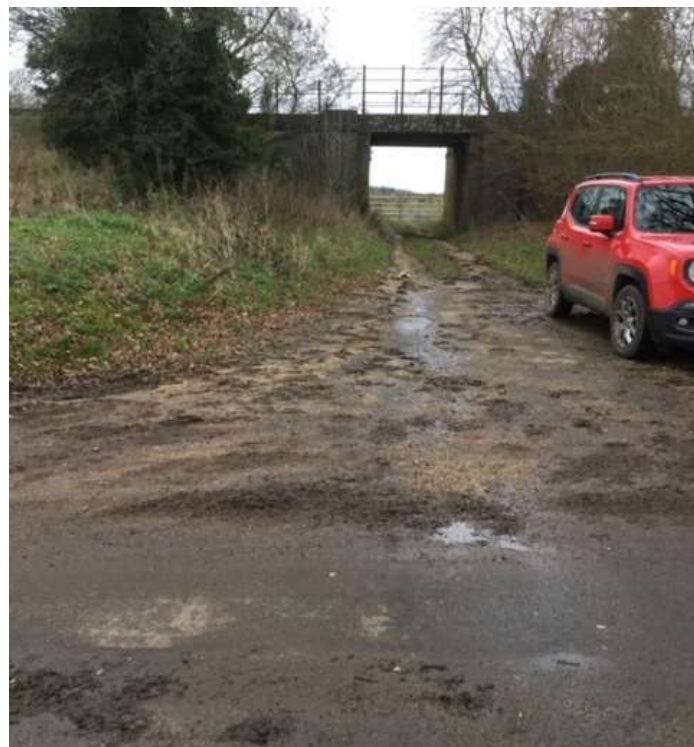
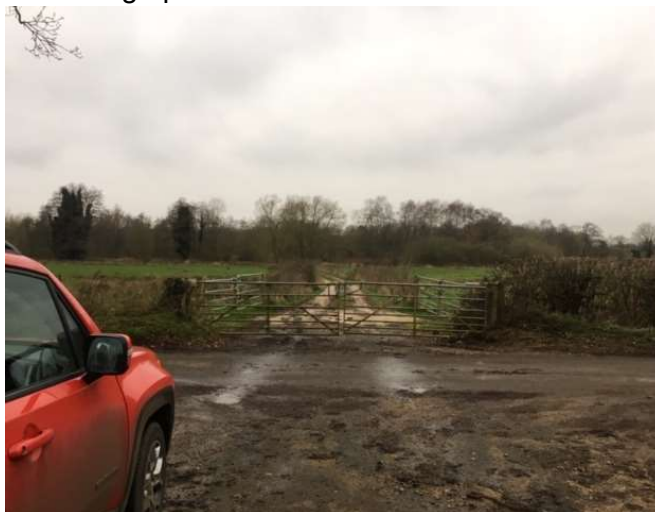
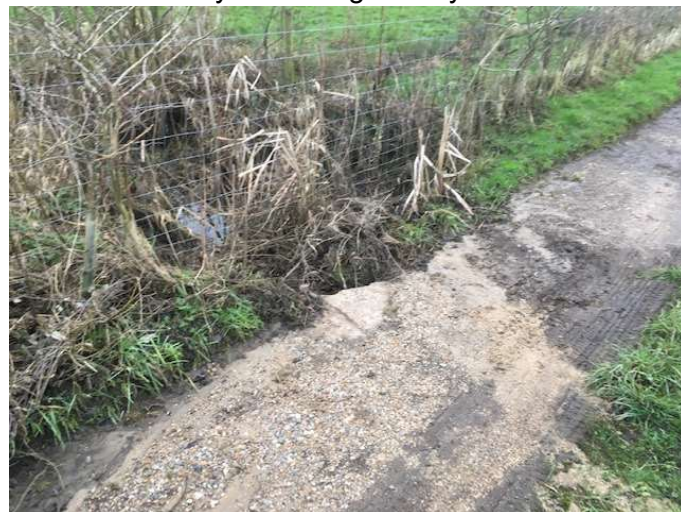
Back up the track across the road there is sediment, sand and gravel running down from beneath a railway bridge (phot, right).

This is ending up in a minor watercourse where the track crosses and may be finding its way to the river.
