Introduction

The survey aimed to repeat a survey of key sites where sediment was found to enter the River Wensum catchment, undertaken in 2010 by APEM Aquatic Scientists for the Environment Agency, which included the River Wensum amongst other English rivers identified as the top failing salmon catchments in England where fine sediment is a known problem.

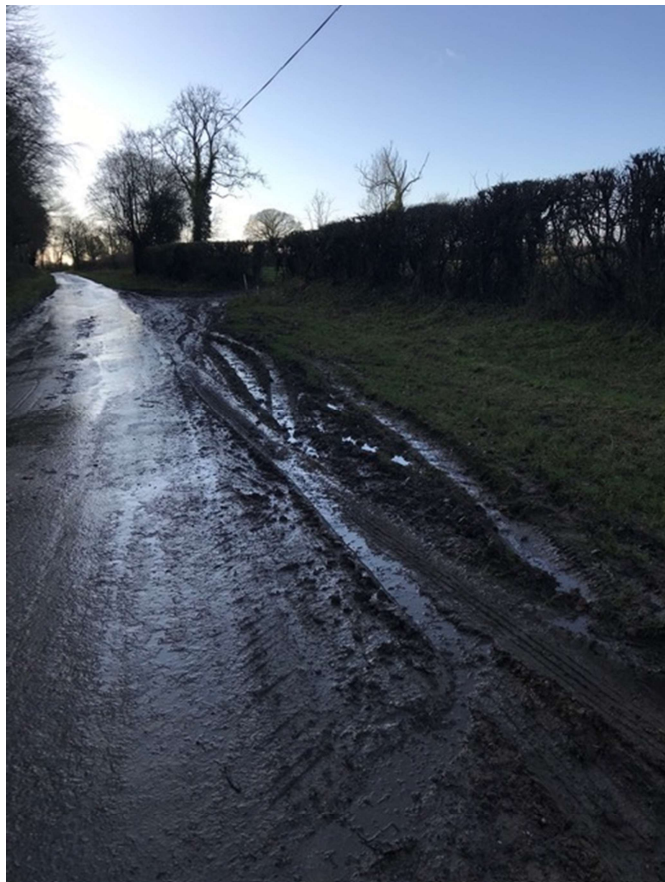
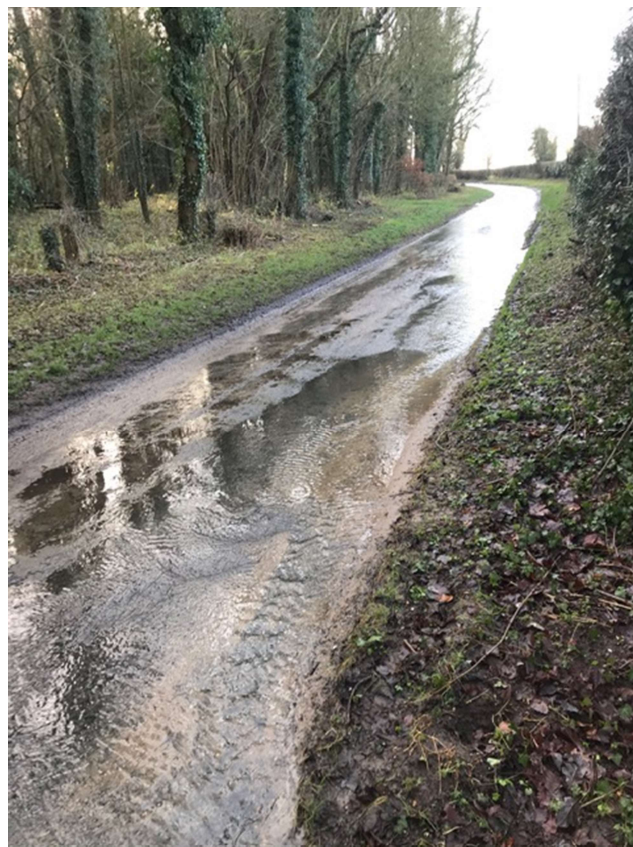
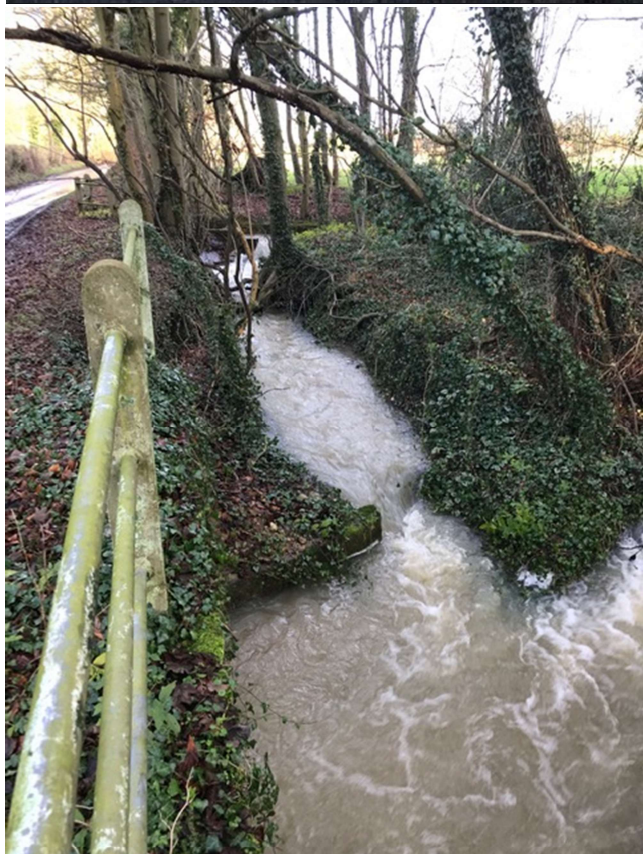
348 Pennyspot E 1 TG0402215902 (Road runoff) (CH)
Pennyspot Beck, nr Elsing Hall

Complicated small beck with weirs and mini sluices, lots of field run off into the beck.
Long hill, silt from farm gateways and verges.

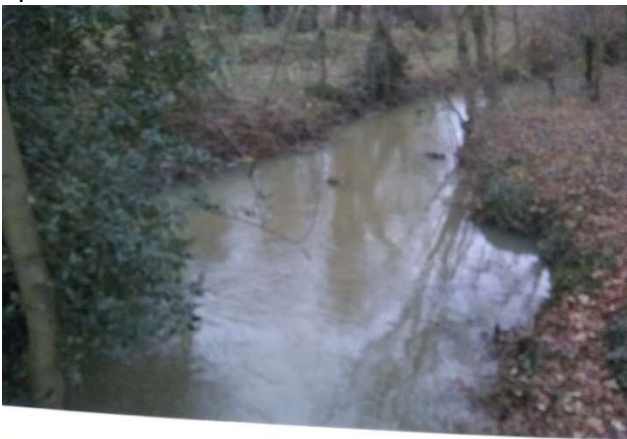
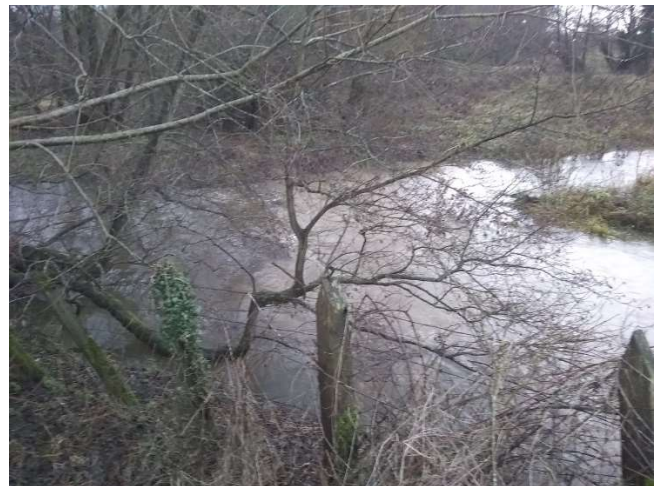
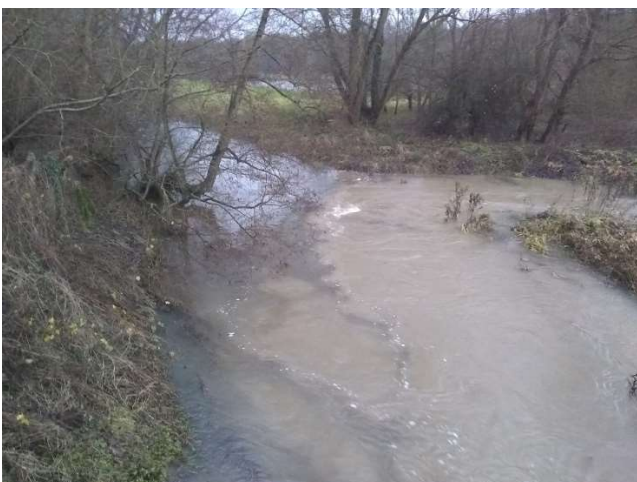
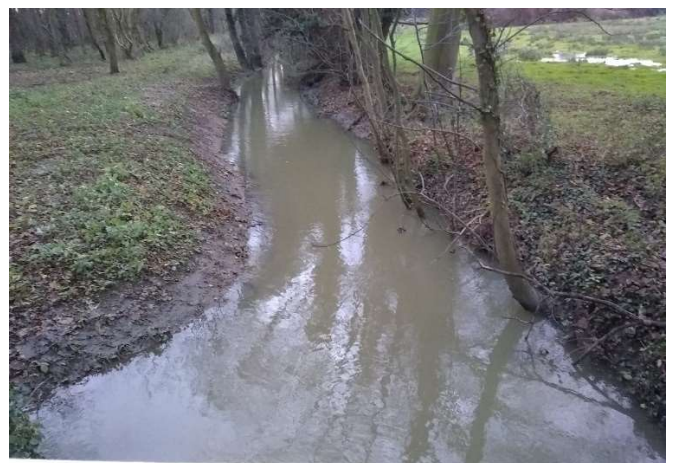
14/1/20 I took these pictures when we had the last flooding event on the River Wensum. The plume of coloured water flowing into the River Whitewater is from the Blackwater River at the confluence just upstream of the Mid Norfolk Railway Bridge above Worthing Mill. The other two pictures are of Penny Spot Beck upstream and downstream of the road bridge again showing that it is carrying a lot of silt. I'm waiting for another flood and then I will be able to check these again and also look for more examples further upstream.
