**RURAL SEDIMENT TRACING
PROJECT**

**RIVER WENSUM CATCHMENT
REPORT**

FINAL REPORT

April 2010

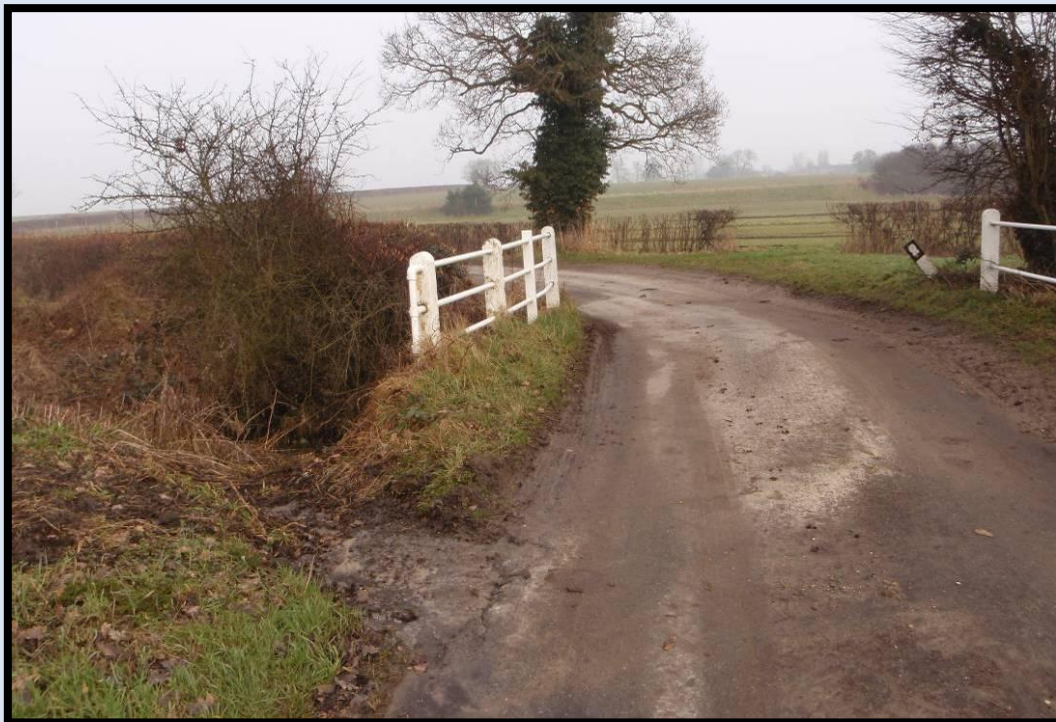
Site 76

Project	410987	River/Beck	Wensum - Reepham
Date	18.02.10	NGR	TG0753523966
Type of input	Fine sediment, sand, fine gravel	Priority	
Description	Road and arable runoff		
Land use	LHB: Rough pasture	RHB: Arable	HIGH
Vegetation	LHB: Grass	RHB: Crops

Road run off from 200m on the left hand bank and 150m from the right hand bank, plus additional arable run off.

Fine sediment is transported into the river at site 76 as road runoff. The runoff was evident 200m up the road on the left hand bank and 150m up the road on the right hand bank. At either side of the road bridge channels have been dug to allow the water to flow into the river. Arable fields are located on the right hand bank and are contributing to the fine sediment runoff which is gathering on the road.

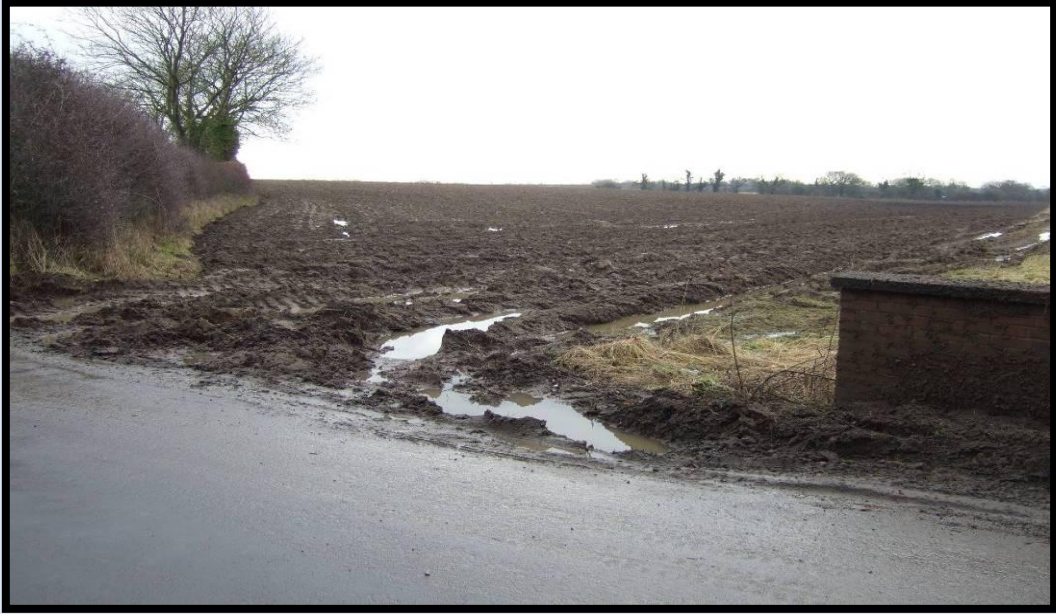
Site 307

Project	410987	River/Beck	Wensum - Foulsham 6
Date	16.02.10	NGR	TG0367727145
Type of input	Fine sediment	Priority	
Description	Road runoff, arable runoff		
Land use	LHB: Broadleaf woodland and tilled land	RHB: Tilled land	HIGH
Vegetation	LHB: Broadleaf trees and grasses	RHB: Bare	
Comments: <p>Thick heavy fine sediment deposits collecting at the side of the road from a large tilled field. This is then running into the channel. There is also run-off from the surrounding land, including the wooded area and the fields on the left hand bank.</p>

Fine sediment enters the river at site 307 via tilled land runoff and road runoff. Several roads converge near to the road bridge and in heavy rain the sediment will run off the roads into the river. Upstream and downstream of the bridge, on the left hand bank, are tilled fields which are just bare soil with runoff entering the river. Tractor activity at the field entrance further contributes to the fine sediment load being input to the river. There is also some runoff from the broadleaved woodland on the left hand bank.

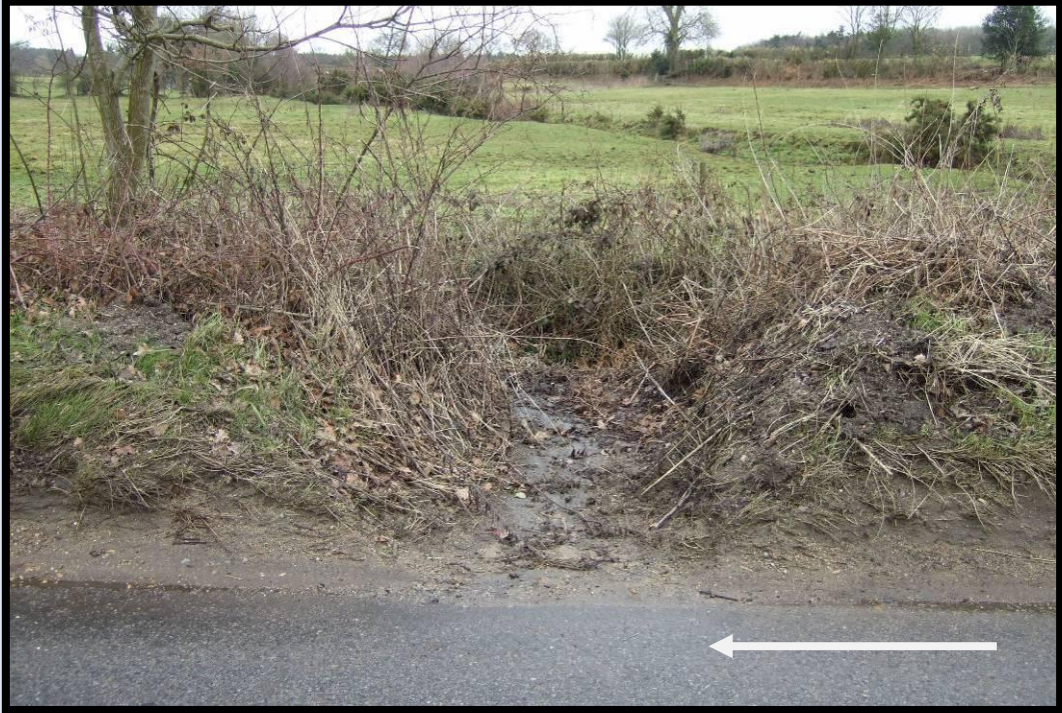
Site 324

Project	410987	River/Beck	Wensum - Foulsham 7
Date	16.02.10	NGR	TG0235629619
Type of input	Fine sediment, sand, fine gravel	Priority	
Description	Road runoff, poaching		
Land use	LHB: Rough pasture	RHB: Rough pas	HIGH
Vegetation	LHB: Grasses	RHB: Grasses	
Comments: Large amount of road run-off creating a channel in the bank adjacent to the road. The channel then flows down and into the main channel potentially discharging a large volume of fine sediment and road run-off.

Fine sediment enters the river at site 324 by several ditches that have been dug out of the bank. This allows the runoff from the road to enter ditches that run perpendicular to the tributary before flowing into the tributary. There was also excessive poaching along both banks of the river.

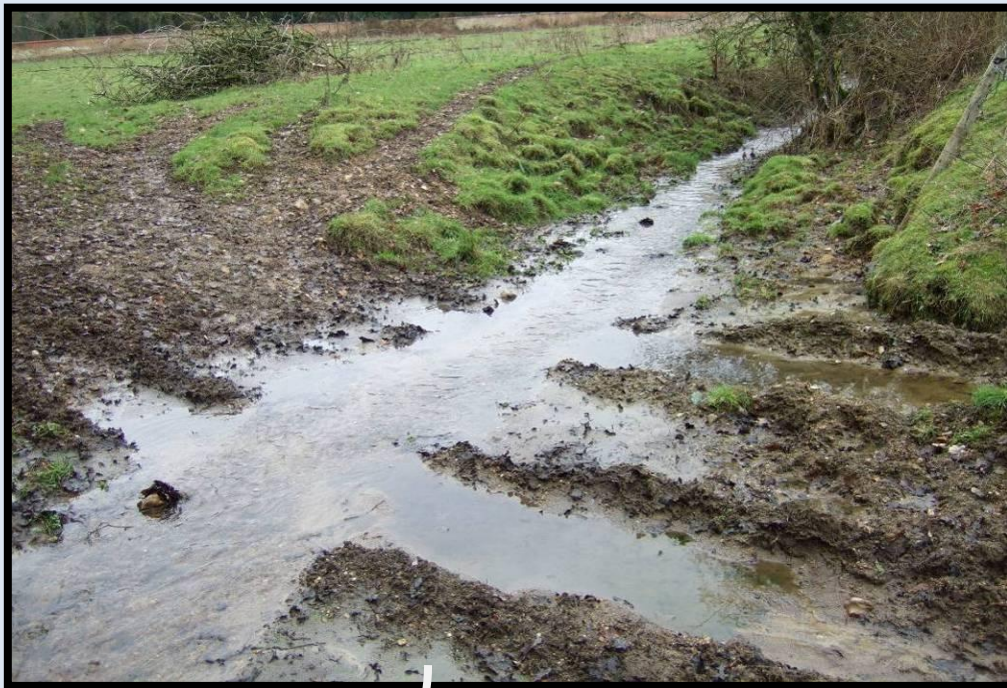
Site 329

Project	410987	River/Beck	Wensum - Foulsham
Date	16.02.10	NGR	TG0221230583
Type of input	Fine sediment, fine gravel	Priority	
Description	Ford and run-off from improved grassland.		
Land use	LHB: Improved grassland	RHB: Rough pas	HIGH
Vegetation	LHB: Grass, shrubs	RHB: Grass, shrubs

Runoff from rutted farmer's track into main channel.

Fine sediment enters the river at site 329 by a combination of sources. There is a large churned up area of bare soil on the left hand bank. It looks like the field is used regularly by tractors and this is causing a large amount of fine sediment to enter the river. There is a minor ford which is again used by the tractors and causes fine sediment input. In a wet weather event all of this bare earth will be transported into the river.

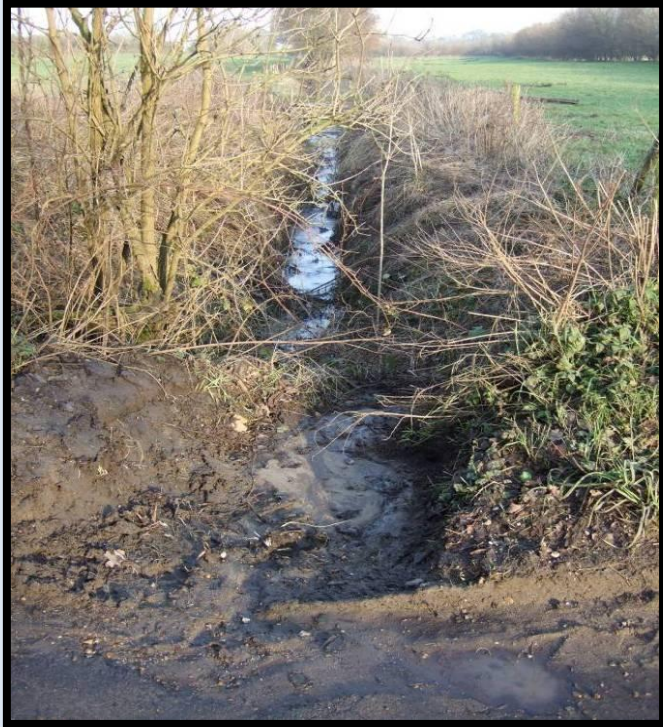
Site 381

Project	410987	River/Beck	Wensum - Reepham
Date	17.02.10	NGR	TG1019520360
Type of input	Fine sediment, sand, fine gravel	Priority	
Description	Road runoff		
Land use	LHB: Rough pasture	RHB: Rough pa	HIGH
Vegetation	LHB: Grasses, shrubs	RHB: Grasses, shrubs	
Comments:			
Relatively large amount of run-off entering stream from road.

Fine sediment enters the river at site 381 via road runoff through several drainage channels. Downstream of the road bridge, on both banks, are improved grassland fields which have muddy entrances to the field which is contributing to fine sediment in the road. Fine sediment deposits can be seen within the channel downstream of the road bridge.

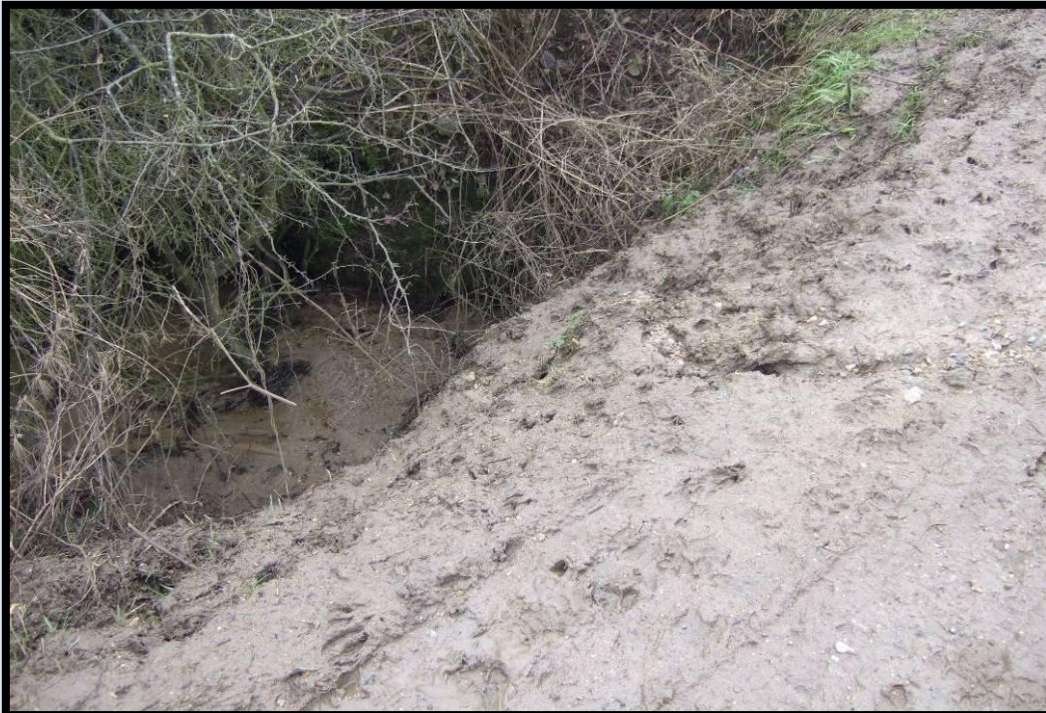
Site 394

Project	410987	River/Beck	Wensum - Cawston 5
Date	18.02.10	NGR	TG1190323791
Type of input	Fine sediment, sand	Priority	
Description	Fine sediment run off from adjacent track		
Land use	LHB: Plantation	RHB: Plantation	HIGH
Vegetation	LHB: Coniferous trees	RHB: Coniferous trees

Fine sediment entering stream from bare, churned up areas used by vehicles. Run-off is flowing down a track and into the stream causing heavy siltation.

Fine sediment is entering the river at site 394 via track runoff. Upstream of the bridge there are coniferous plantations which have been accessed regularly by vehicles. This has caused several areas to be churned up close to the river. In heavy rainfall this earth is washed into the river and fine sediment deposits can clearly be seen downstream of the bridge.

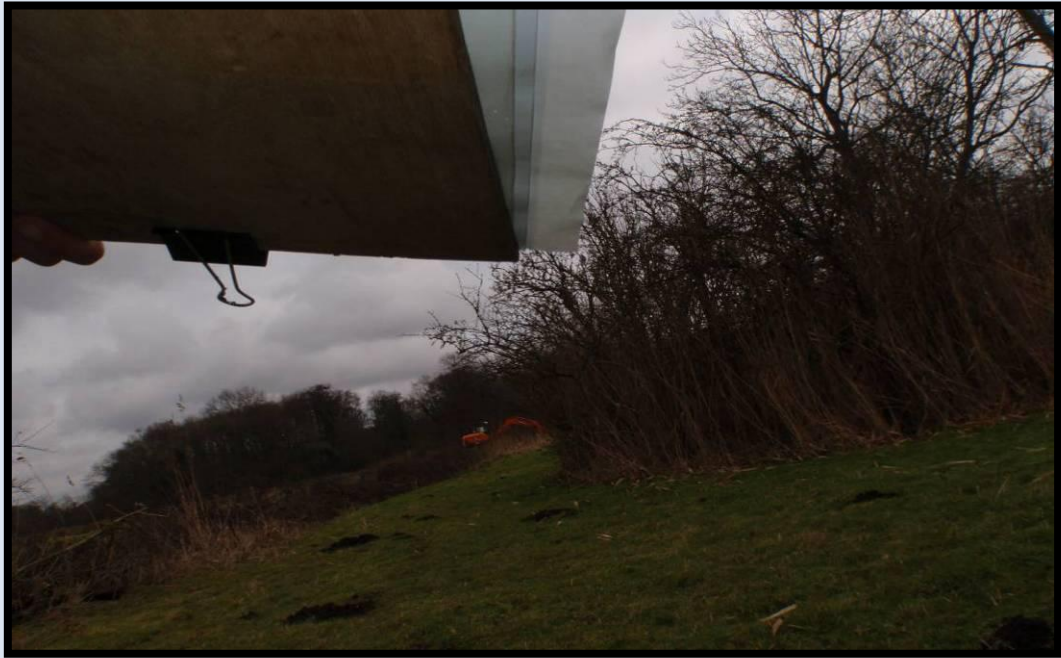
Site 101

Project	410987	River/Beck	Wensum – South Raynham	
Date	16.02.10	NGR	TF8803124056	
Type of input	Fine sediment, dredged material	Priority		
Description	Channel dredging			
Land use	LHB: Grassland	RHB: Grassland	HIGH	
Vegetation	LHB: Grasses	RHB: Grasses		
Comments:				
Digger lifting fine sediment from drain and dumping on field. Run off into drain, clear plume of fine sediment downstream.

Fine sediment was being actively transported into the channel at the time of this survey. A digger was seen to be involved in bank clearing and channel dredging. Any fine sediment that was being removed from the channel was placed in the field beside the channel. Downstream of where this was occurring was extremely turbid and fine sediment deposits were visible. The piles of earth that were placed in the field would also contribute to fine sediment in the channel during heavy rain.

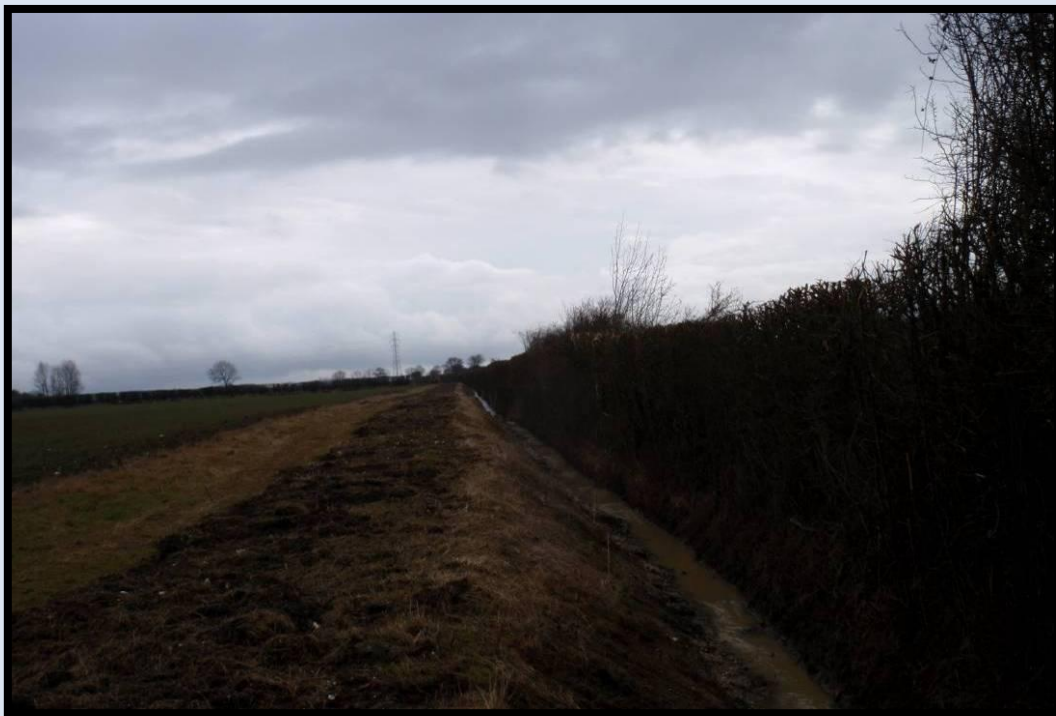
Site 112

Project	410987	River/Beck	Wensum West
Date	16.02.10	NGR	TF8821022770
Type of input	Fine sediment, topsoil	Priority	
Description	Run off from arable field		
Land use	LHB: Arable field	RHB: Arable field	HIGH
Vegetation	LHB: Short crops	RHB: Short crops

Modified banking with a steep downward slope. Immediately above is a tilled field creating siltation runoff into the main channel.

Fine sediment and clay enter the channel at site 112 as runoff from arable fields. The ditch has been resectioned and over deepened leaving bare soil on the banks. In a rainfall event this soil will be transported straight into the river. This combined with the runoff from the arable fields meant that the water was visibly turbid approximately 100m from the source.

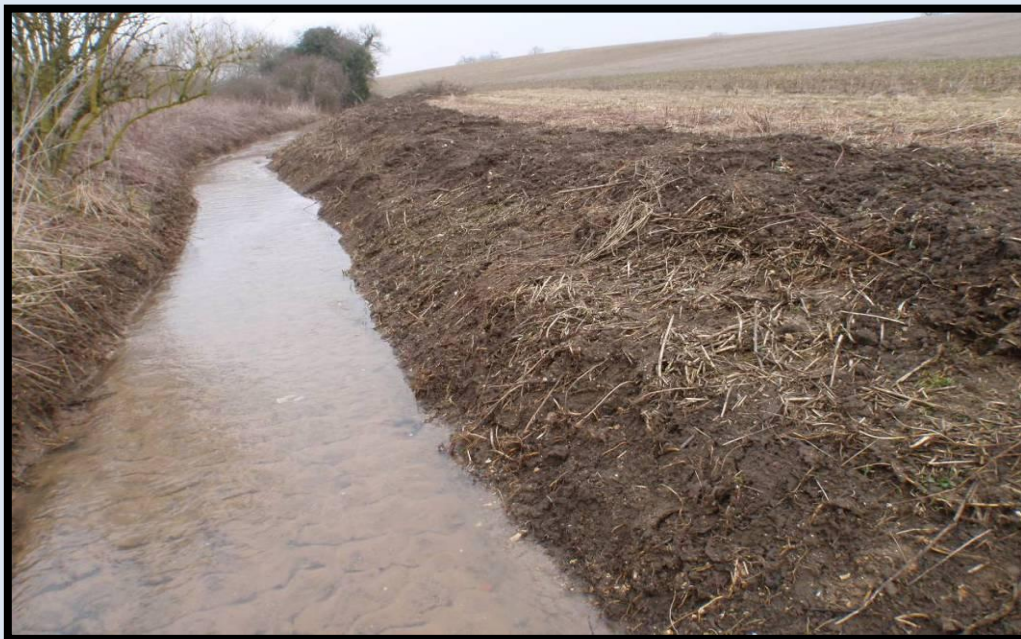
Site 128

Project	410987	River/Beck	Wensum - Racecourse tributary
Date	17.02.10	NGR	TF9314627793
Type of input	Fine sediment, topsoil	Priority	
Description	Bank clearance		
Land use	LHB: Arable	RHB: Arable	HIGH
Vegetation	LHB: Short stubble	RHB: Short stubble	
Comments:			
Bare soil over a 500m stretch of bank.

Fine sediment enters the channel at site 128 as runoff from arable fields. The channel has recently been resectioned and over deepened over a 500m stretch and the excavated soil has been placed next to the water course. This has left exposed bare soil which is subject to runoff in a rainfall event. Stubble fields are located on both banks and this is also contributing to fine sediment flowing into the channel. From the photograph you can see the extent of the siltation in the channel and this extends much further downstream.

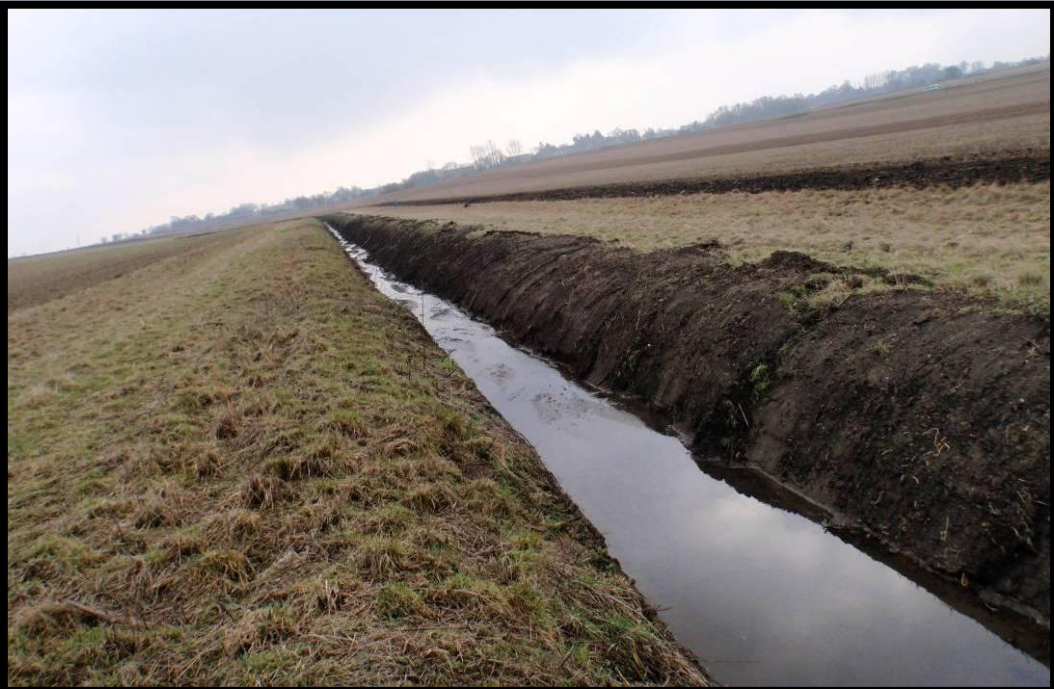
Site 135

Project	410987	River/Beck	Wensum - Racecourse Tributary
Date	17.02.10	NGR	TF9247727526
Type of input	Fine sediment, topsoil	Priority	
Description	Channel clearance		
Land use	LHB: Arable	RHB: Arable	HIGH
Vegetation	LHB: Grasses, crops	RHB: Grasses, crops	
Comments:			
Heavily modified, over-deepened channel with straightened plan form.

Fine sediment enters the channel at site 135 as arable runoff due to bank side clearance. The channel has been resectioned, over deepened and straightened. This has exposed approximately 500m of bare soil along the bank which will runoff into the channel with any amount of rain. The land use on either side of the channel is stubble fields and due to the slight incline of the fields any surface water will runoff straight into the channel taking any loose fine sediment with it.

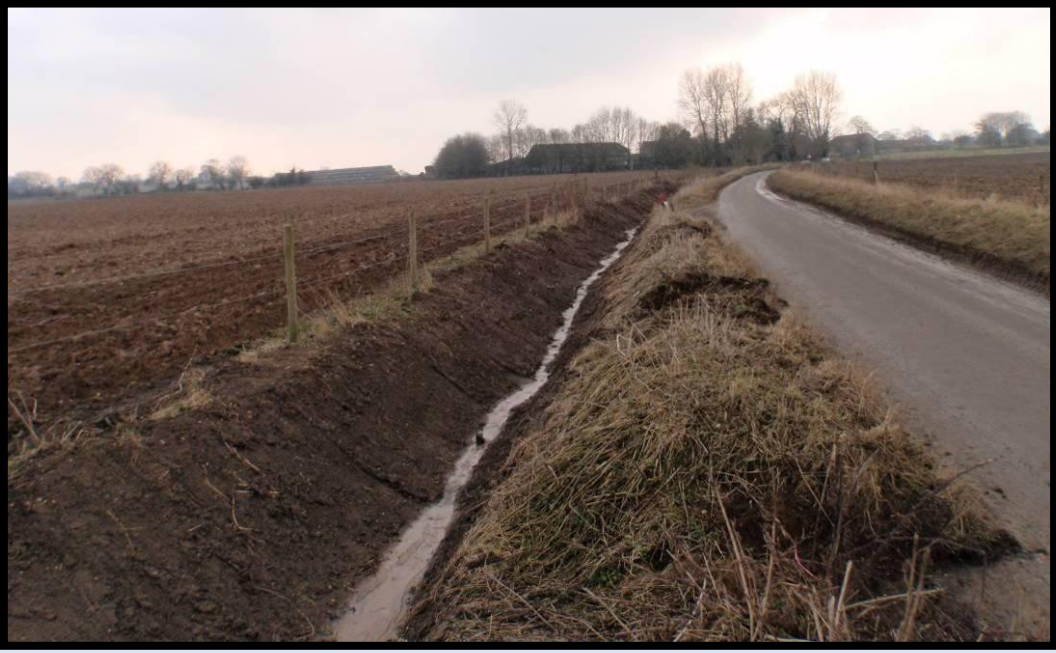
Site 136

Project	410987	River/Beck	Wensum - Racecourse Tributary
Date	17.02.10	NGR	TF9259927024
Type of input	Fine sediment, topsoil, fine gravel	Priority	
Description	Bank clearance and arable runoff		
Land use	LHB: Road, arable field	RHB: Arable field	HIGH
Vegetation	LHB: Grasses	RHB: Bare soil	
Comments: Runoff from arable fields and road combined with bank clearance resulting in fine sediment input into the river.

Fine sediment enters the channel at site 136 as arable and road runoff and bank clearance. The channel has recently been resectioned and over deepened leaving bare soil banks which are causing fine sediment input into the channel. On either side of the channel are ploughed fields with runoff which is contributing to the channel being completely silted up. Another contributing factor is road runoff and channels have been cut into the bank to divert the water from the road into the channel.

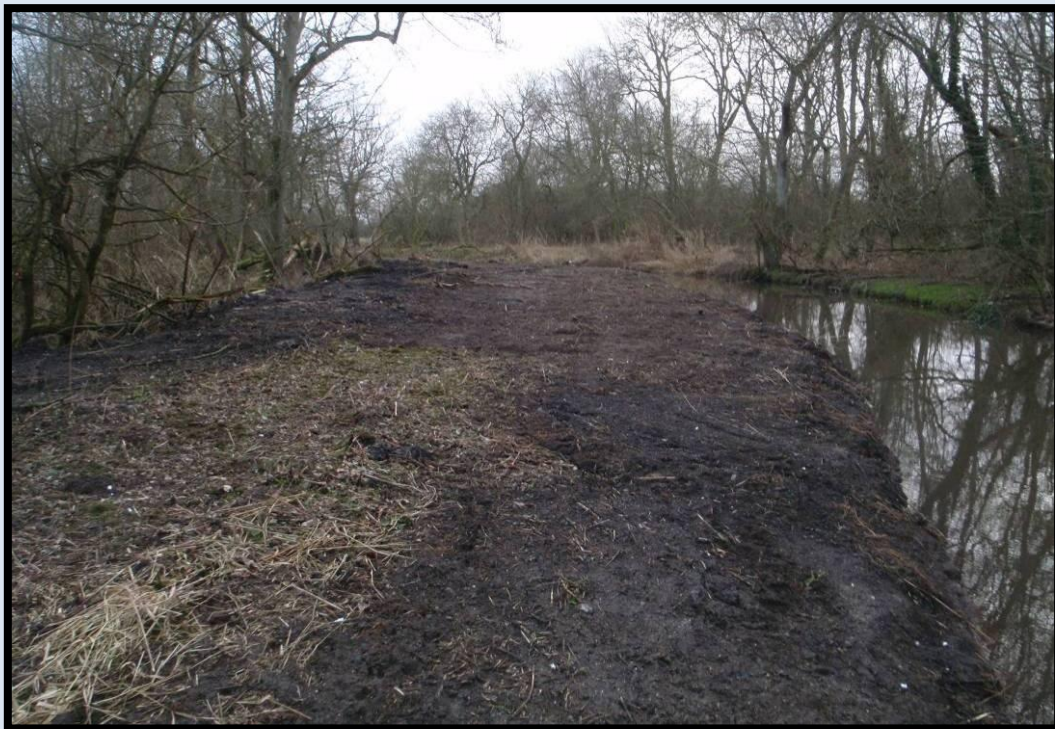
Project	410987	River/Beck	Wensum
Date	16.02.10	NGR	TF8723627252
Type of input	Fine sediment, topsoil	Priority	
Description	Runoff from bare soil on banks		
Land use	LHB: Woodland	RHB: Woodland	HIGH
Vegetation	LHB: Tree, shrubs	RHB: Trees, shrubs, grass

Grass/hay cutting, tree felling on both banks creating exposed soil. Relatively large area of bare ground allowing fine sediment to run-off and enter channel.

Site 257 is characterised by periodic expanses of loose silty topsoil, for approximately 750m, through the wooded area of Tatterford Common. Sources are present on both banks and are caused by a combination of hay cutting and tree felling, which had been recently undertaken. Fine sediment enters the watercourse entrained in overland flow during periods of high rainfall.

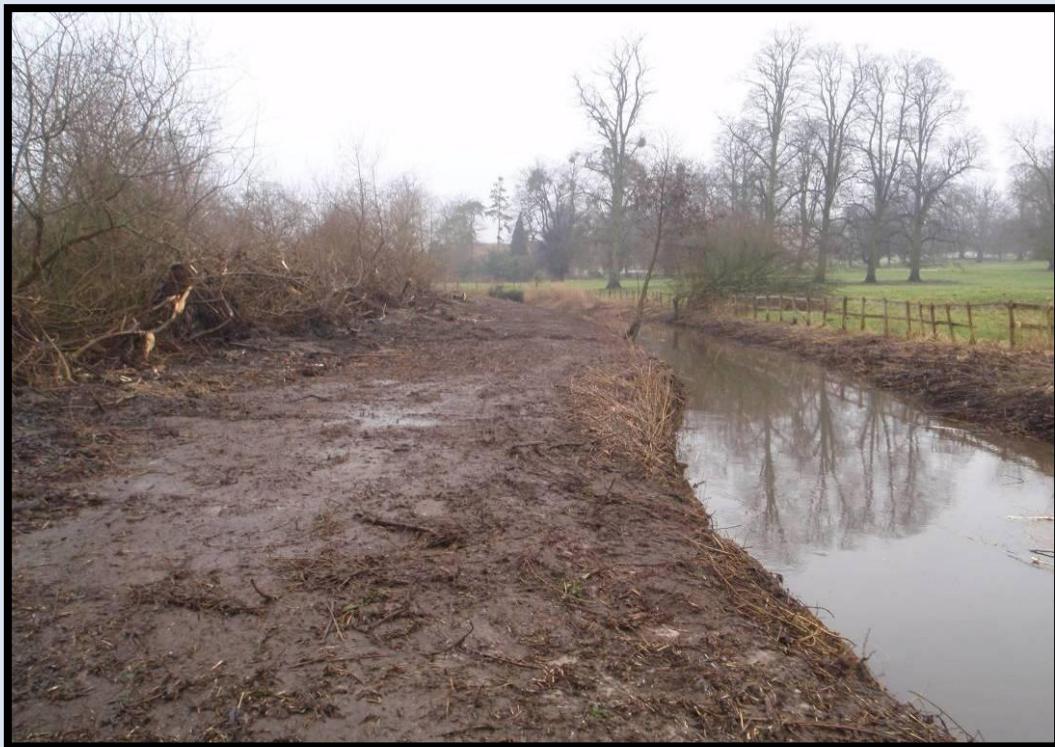
Project	410987	River/Beck	Wensum
Date	17.02.10	NGR	TF8752025985
Type of input	Fine sediment, topsoil	Priority	
Description	Runoff from bare soil on banks		
Land use	LHB: Woodland	RHB: Pasture, a improved grassla	HIGH
Vegetation	LHB: Broadleaf trees	RHB: Grass

750m of bare top soil left following bank clearance, allowing fine sediment to run off and enter channel.

Fine sediment enters the watercourse at Site 265 entrained in overland flow during periods of high rainfall. Bare unconsolidated silty topsoil is found periodically on both banks for approximately 750m upstream of the start NGR. These fine sediment sources are a product of recent hay cutting.

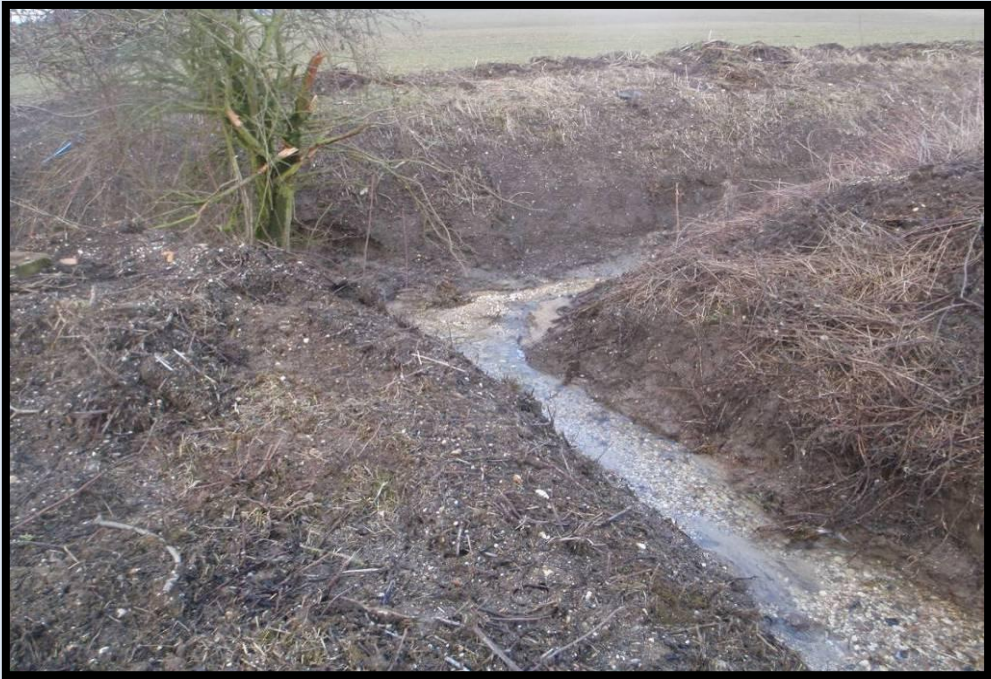
Project	410987	River/Beck	Wensum - Great Ryburgh
Date	17.02.10	NGR	TF9376626018
Type of input	Fine sediment, topsoil	Priority	
Description	Re-sectioned bank, runoff from unconsolidated top soil		
Land use	LHB: Pasture	RHB: Pasture	HIGH
Vegetation	LHB: Grasses	RHB: Grasses	
Comments: Large drainage channel with a considerable amount of loose top soil entering the channel.

Site 283 is characterised by extensive recent bank resectioning of this field drainage channel. The works have left the banks with no vegetation and unconsolidated fine sediment which enters the watercourse entrained in overland flow during periods of high rainfall. The steep gradient of the resectioned channel has lead to bank collapse in places.

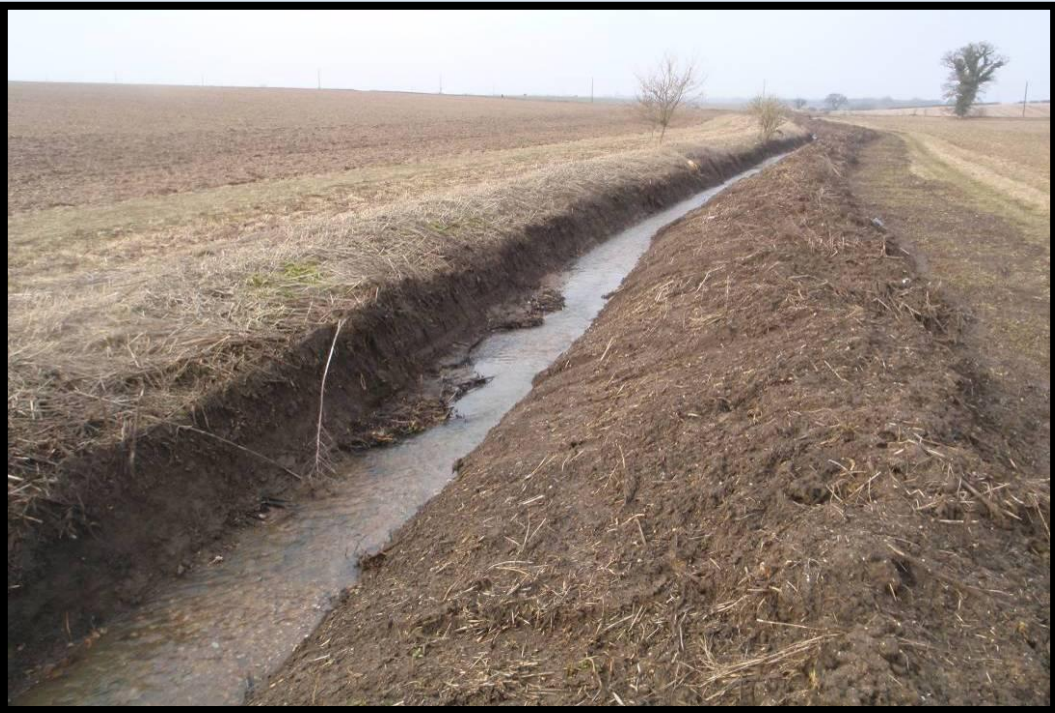
Site 286

Project	410987	River/Beck	Wensum - Great Ryburgh
Date	17.02.10	NGR	TF9337426736
Type of input	Fine sediment, topsoil	Priority	
Description	Re-sectioned bank, runoff from exposed soil		
Land use	LHB: Tilled field	RHB: Tilled field	HIGH
Vegetation	LHB: Grain crop	RHB: Grain crop	
Comments: Heavily modified drainage channel about 750m long. There was evidence of bank collapsing and potential for a large amount of loose topsoil to flow into the channel.

Recent resectioning of this field drainage channel has left large source areas of unconsolidated silty topsoil. Sources are present periodically on both banks for approximately 1km downstream of the start NGR. Fine sediment enters the watercourse entrained in overland flow during periods of high rainfall.

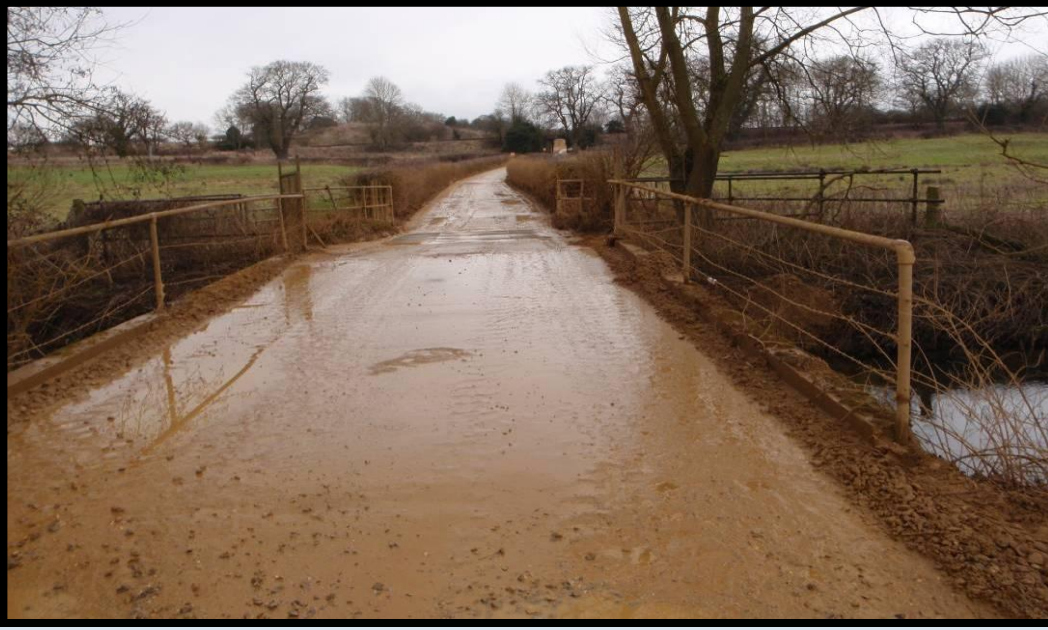
Site 30

Project	410987	River/Beck	Wensum - Blackwater		
Date	16.02.10	NGR	TF9898618419		
Type of input	Fine sediment, sand, clay, fine gravel	Priority			
Description	Sand and fine sediment run off from road				
Land use	LHB: Rough pasture, woodland	RHB: Rough pasture	HIGH		
Vegetation	LHB: Grass, trees	RHB: Grass, trees			
Comments:					
Track crossing river was very sandy. Vegetation to both sides of track was yellow from sand spray. Piles of grit and sand ran onto track and into the river.

Fine sediment, sand and gravel enter the channel at site 30 as track runoff. The track was very sandy due to vehicles transporting material from the sand/gravel pit. On the left hand bank are piles of gravel and sand which produce runoff onto the track and then into the channel in rainy conditions. Entering the river from the left hand bank is a tributary which is very sandy due to rough pasture runoff. Woodland is also present on the left hand bank and this is contributing to fine sediment input into the river.

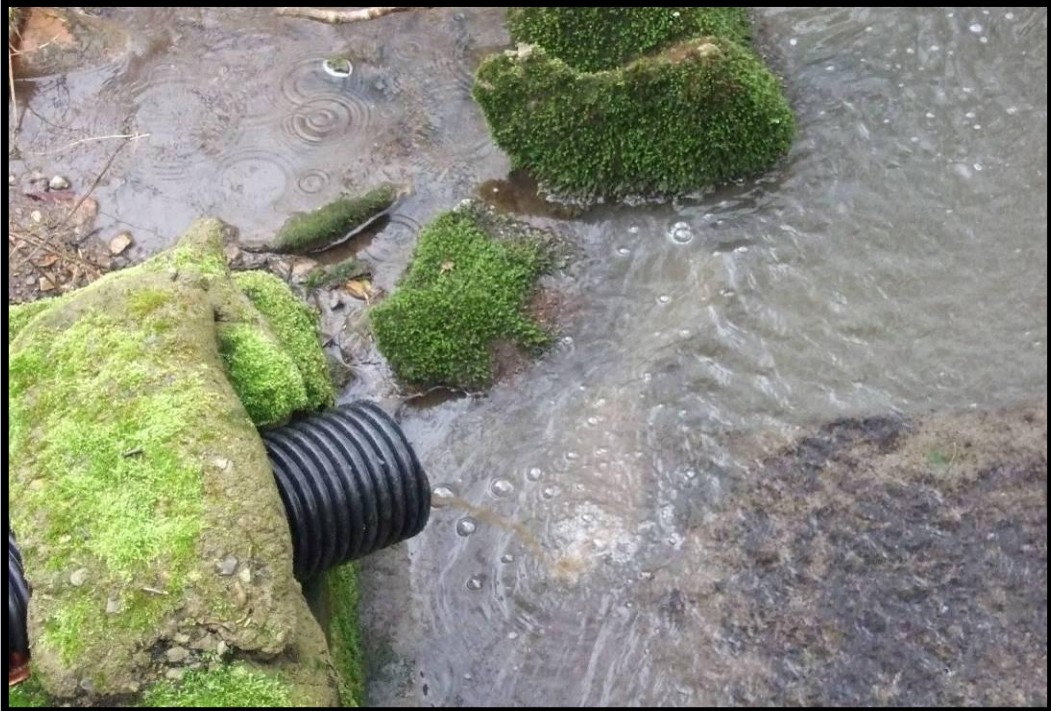
Site 348

Project	410987	River/Beck	Wensum - Pennyspot E 1
Date	16.02.10	NGR	TG0402215902
Type of input	Fine sediment, fine gravel	Priority	
Description	Run off from road and pipe		
Land use	LHB: Broadleaf woodland/ rough pasture	RHB: Broadleaf woodland/ road	HIGH
Vegetation	LHB: Trees, grasses, shrubs	RHB: Trees, grasses, shrubs	
Comments: Drainage pipe discharging into channel with evidence of fine sediment plume and deposits. There is also run- off from the road that crosses the stream.

Fine sediment enters the river at site 348 via a road drainage pipe. There were significant amounts of fine sediment being transported down the road and a plume was visible in the channel. This picture was taken in relatively dry weather so in a wet weather event the amount of fine sediment entering the channel will increase significantly.

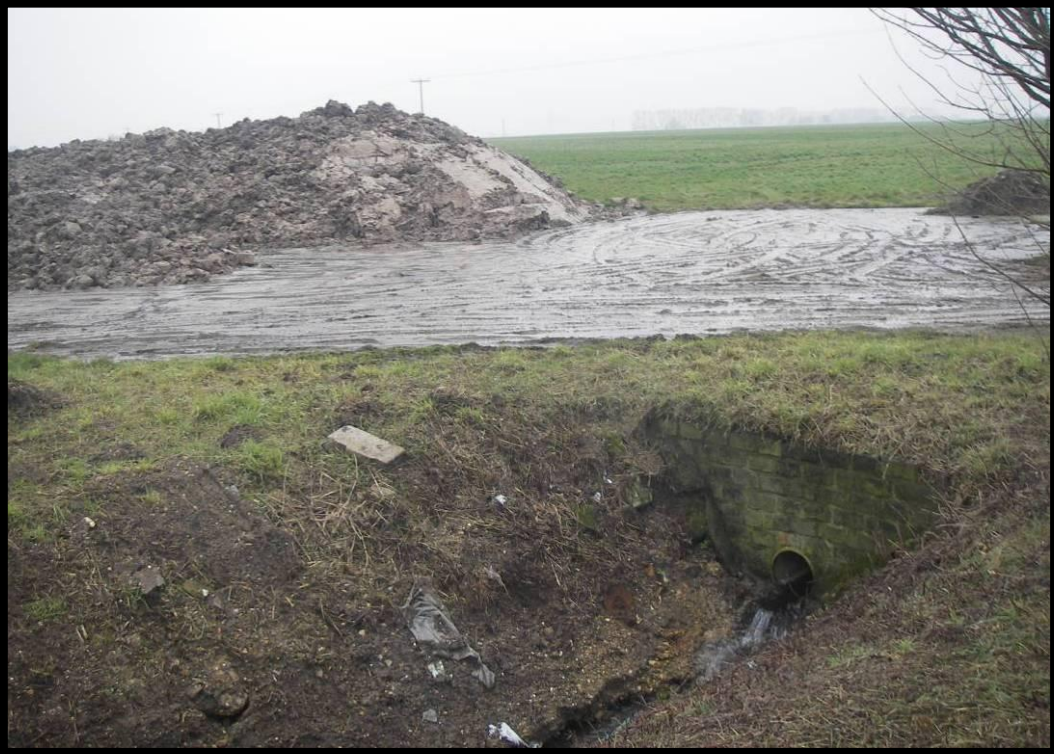
Site 422

Project	410987	River/Beck	Wensum - Wendling
Date	17.02.10	NGR	TF9197612941
Type of input	Fine sediment, clay, organic	Priority	
Description	Runoff from road, track and excavated top soil pile		
Land use	LHB: Rough pasture	RHB: Rough pa	HIGH
Vegetation	LHB: Grasses	RHB: Grasses	
Comments:			
Fine sediment runoff from A47, a farm track and a large mound of clay and manure.

Fine sediment enters the channel at site 422 as road runoff from the A47 and from a regularly used farm track. Running parallel to the A47 are drainage ditches which are carrying fine sediment from these roads into the river. At the edge of the farm track is a mound of clay and manure which is producing runoff in any rainfall event.

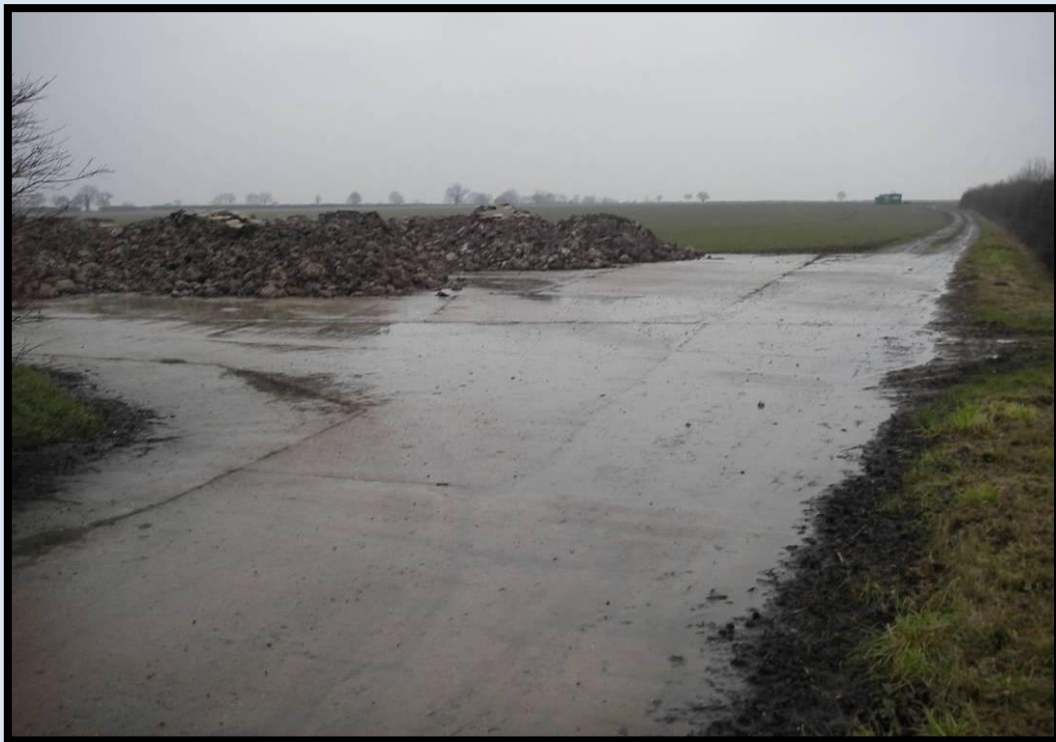
Site 427

Project	410987	River/Beck	Wensum - Wendling
Date	17.02.10	NGR	TF9023413711
Type of input	Fine sediment, organic	Priority	
Description	Runoff from top soil pile, over adjacent farm track into beck		
Land use	LHB: Agricultural	RHB: Agriculture	HIGH
Vegetation	LHB: Grasses	RHB: Grasses

Large heap of manure and earth with fine sediment freely running off across a track and into the main channel.

Fine sediment enters the channel as track runoff from a mound of earth and manure and also from the arable field which is located behind the mound. This photograph was taken in light rainfall and it was evident that there was fine sediment flowing across the track and into the channel. In heavy rain the fine sediment load in the channel will be increased.

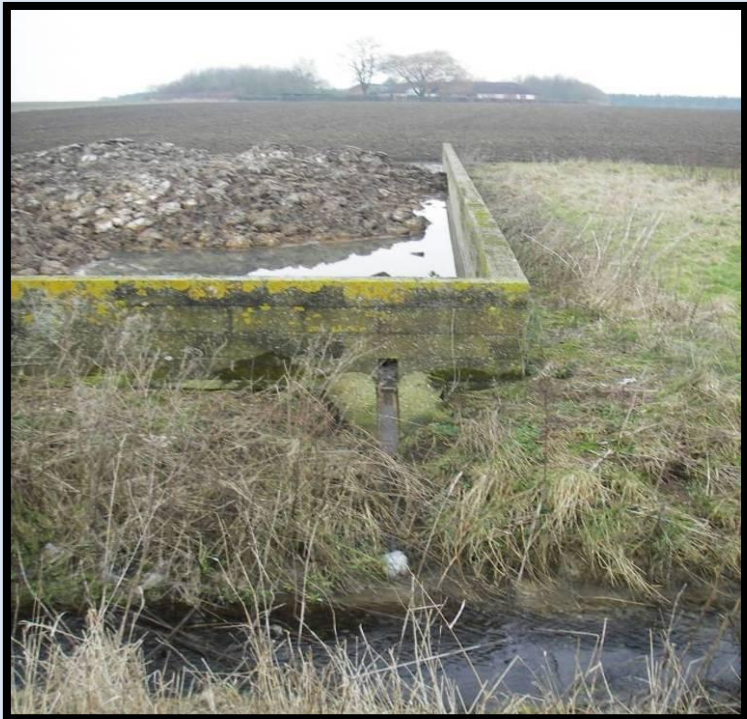
Site 433

Project	410987	River/Beck	Wensum - Wendling
Date	17.02.10	NGR	TF9075012831
Type of input	Fine sediment, organic	Priority	
Description	Top soil pile running off via drain directly into stream		
Land use	LHB: Agricultural	RHB: Agricultural	HIGH
Vegetation	LHB: Grasses	RHB: Grasses, short crops	
Comments:			
Walled area containing earth and possibly manure discharging into the channel via drainage channels.

Piles of earth have been deposited next to the river and are entering the channel at site 433. The mound of earth is contained within a concrete platform with several drainage channels emerging from this. These transport a significant amount of fine sediment and organic matter into the channel. On both banks there are ploughed fields which have the potential to produce a significant amount of runoff into the river.

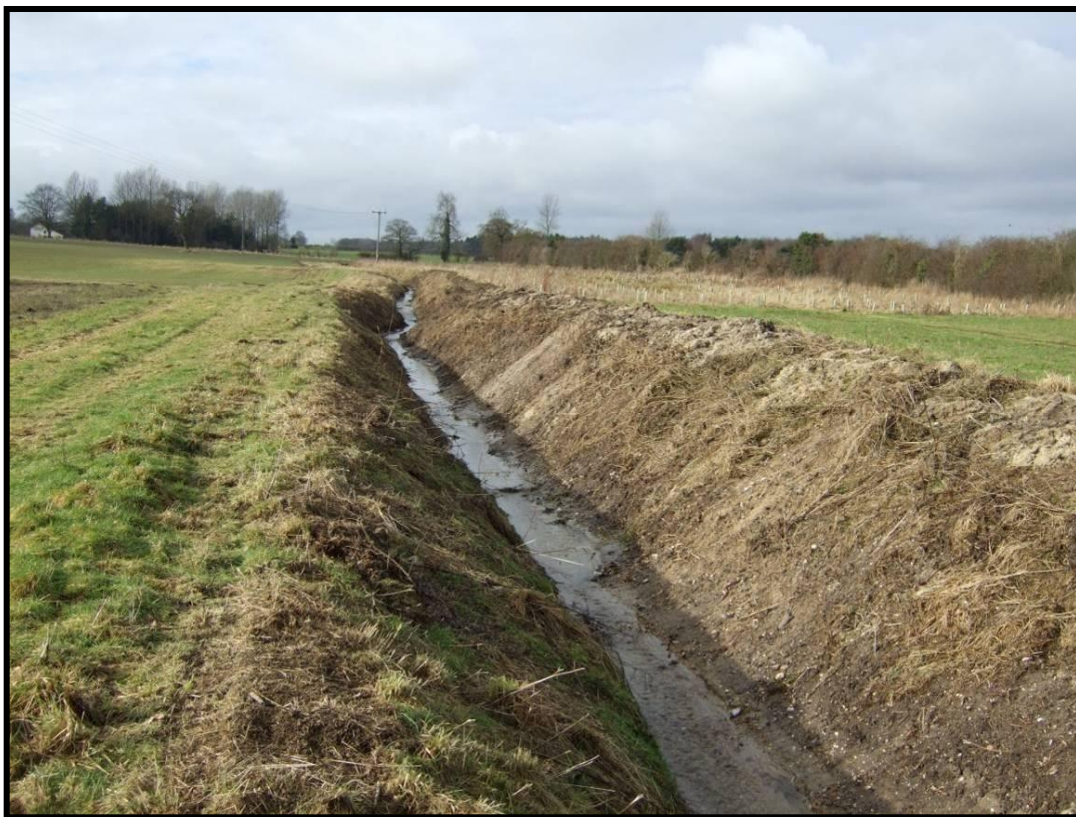
Figure 1. Resectioned bank with bare soil prone to slippage during wet weather.

Bank clearance and resectioning of channels was common throughout the Wensum survey area (Figure 1). Where channels had been cleared of vegetation and over deepened, bare soil may be subject to washing into the channel during rainfall events. This type of fine sediment input accounted for 45% of all Grade 1 sources on the Wensum (Figure 2).

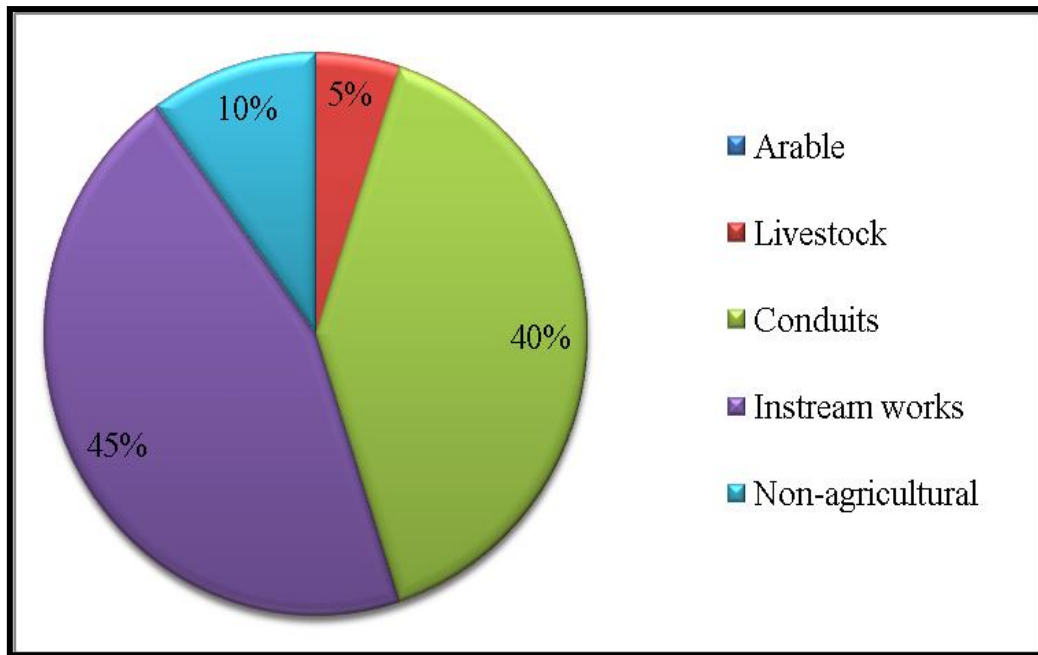
Figure 2. Percentage contribution of the Grade 1 sources in the Wensum catchment.

Other common fine sediment sources reported during the baseline survey were inputs from roads, farm tracks and drainage ditches, which contributed 40% of all Grade 1 reports. However, it is thought likely that these pathways are acting as conduits for runoff from other sources, notably arable farmland which was widespread throughout the survey reach. Wet weather surveys would help determine the origin of many of these sources. Direct fine sediment inputs to streams from livestock pasture comprised only 5% of sources (Figure 2) and there was no direct input from arable land.
