# River Wensum Restoration

## Fish Monitoring Report

<b>Project Title</b>	<i>River Wensum Restoration Fish Monitoring Report</i>
<b>Project reference</b>	03065
<b>Date</b>	05/04/2022
<b>Client</b>	Environment Agency

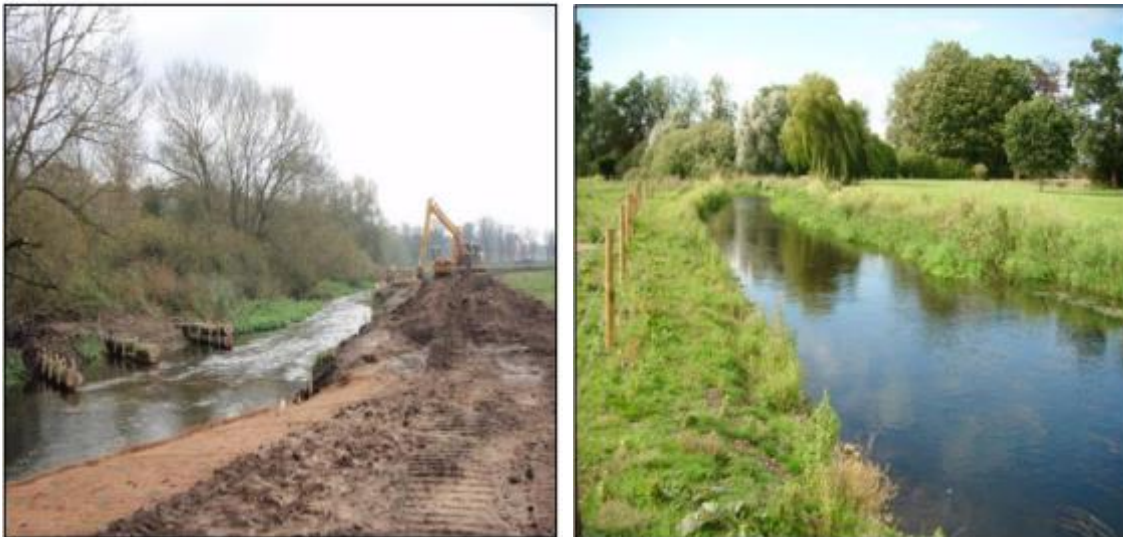
**Figure 5-1. LH- Construction during November 2009, shows woody debris flow deflectors and berm creation. RH- Restored reach in August 2010. Source: EA RWRS fact sheets combined**

Flow diversification throughout the reach was achieved through large scale bed raising of up to 1m in places, using locally sourced gravel reject. In certain locations additional raising to produce four glide habitats was achieved through the addition of graded gravels. Further habitat improvements were produced by altering the river planform by re-sectioning and channel narrowing works, using brushwood mattresses and large woody debris flow deflectors. Improved connectivity of the river to its floodplain was also achieved, by lowering the adjacent spoil embankment in selected locations on the true right-hand bank.

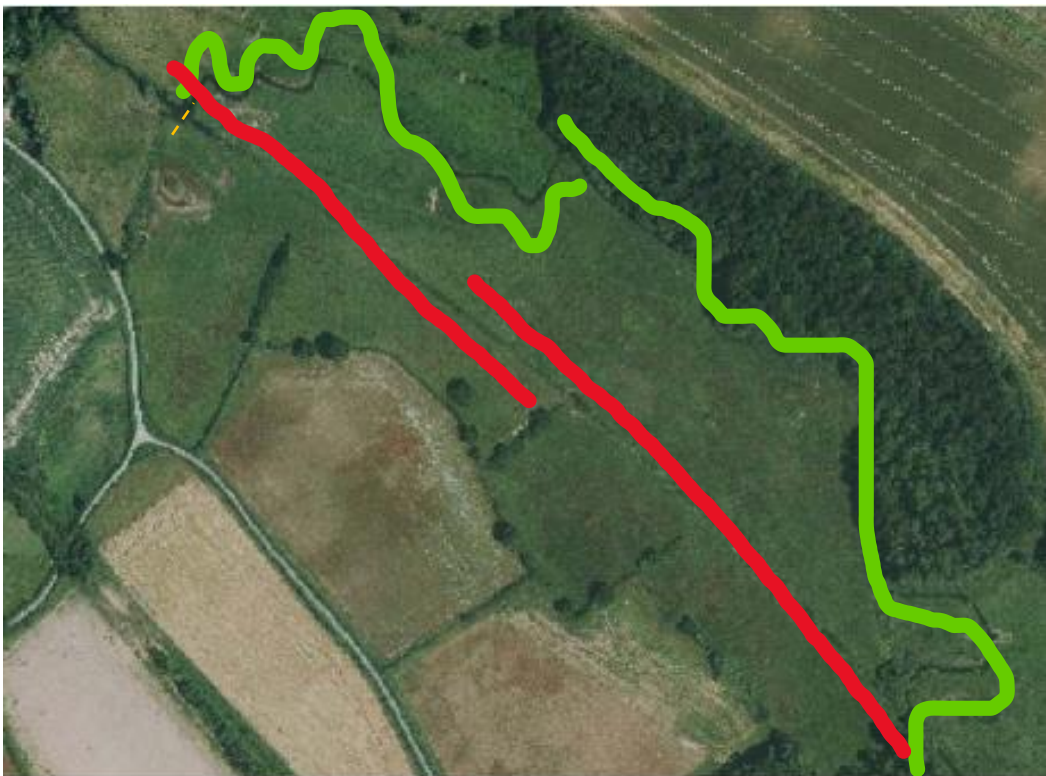
**Figure 5-27** Green line indicates the reinstated historic channel. Yellow dashed line marks the location of the plug. Red line indicates the straight, engineered channel which has now become a backwater habitat.

During the late 1800s, the historic river course was bypassed by a new channel. This straight, engineered channel was deep and lacked flow and habitat diversity, and as a result of its incised form, had minimal connection to the floodplain. A key part of this restoration scheme was to excavate a new channel to connect the river to its former, historic channel (Figure 5-27). The straightened channel was also plugged to divert flows into the new river course. The old river course now provides backwater habitat and acts as a secondary channel in high flow events.

Within the new meandering channel, deeper pools have been created on many of the bends to provide slower water for preferential deposition, increasing the functionality of the glides by reducing sediment flow across them. Deep sections also help limit encroachment by marginal vegetation and providing refuges for fish and other wildlife. The restored reach also includes areas of shallow water at the channel edge and a number of bays and backwaters connected to the main channel. In-channel woody debris has been installed to vary the flow and planform, creating physical habitat for many species of plants, invertebrates, and fish. Native species of tree and shrub have been planted (and fenced from livestock) in strategic locations to provide areas of riparian shade. Lateral berms and gravel glides have also been introduced within the straightened channel, upstream of the new link to the historic channel, to provide a more diverse environment.

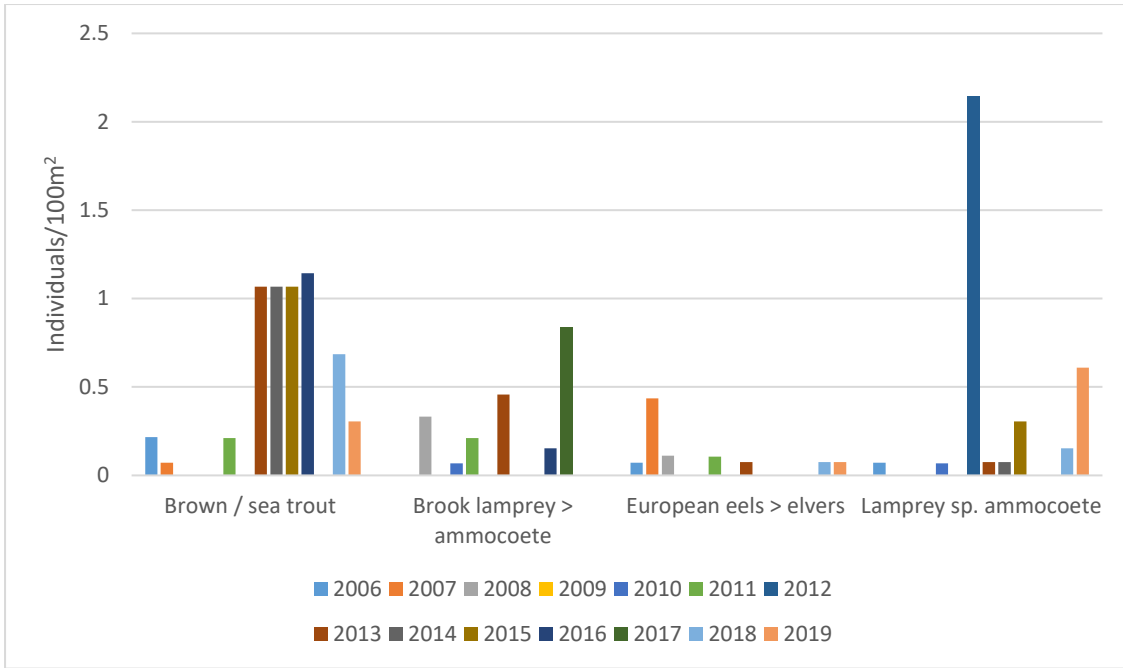
Figure 5-30. Abundance estimates of other fish species within the survey reach, 2006-2019

Notable changes in abundance were observed for eight out of the seventeen species recorded at the site (47%). The most significant increases were for brown trout, gudgeon and all minor species (Figure 5-29 & Figure 5-30). Trout biomass increased from 6% in 2010/2011, to almost half the biomass following the restoration works in 2013, highlighting the significant increase in suitable habitat for this species.

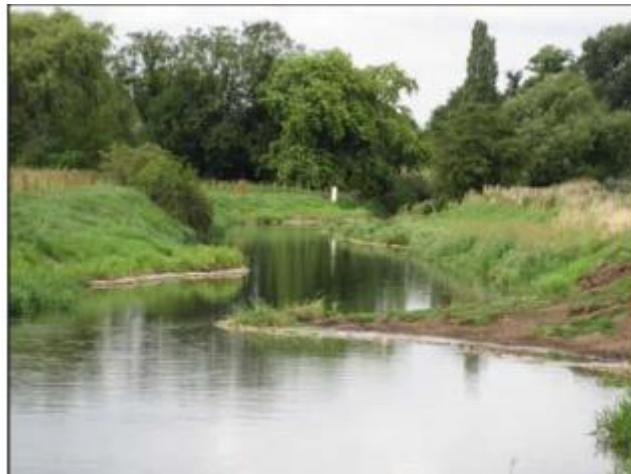
**Figure 5-35. Restored reach, post restoration, August 2012. (Source: EA RWRS fact sheets combined)**

Restoration in this reach primarily entailed the installation of gravel glides, pools, lateral shelves (berms) and woody debris. Some partial removal of spoil embankments was also undertaken to improve floodplain connectivity. A small meander loop, bypassed as part of a land drainage scheme in the 1950s, has also been reinstated by plugging the existing straight channel to divert flows around the loop. Once de-silted, the meander returned to the natural hard bed, consisting of pockets of gravel and chalk, providing excellent habitat. Selective planting of native species of tree and shrub has also taken place on the open stretches of channel to complement the other restoration features.

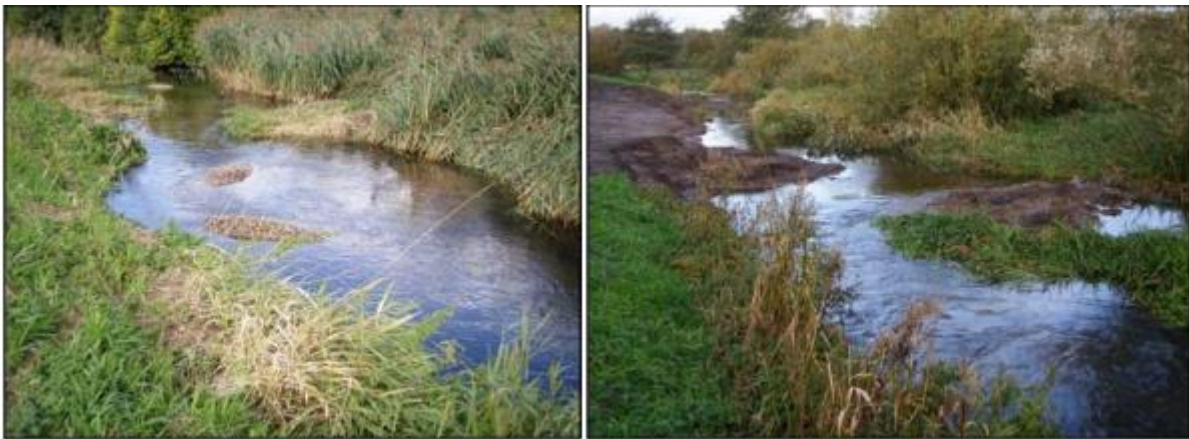
**Figure 5-44. Restored river channel with clean gravel beds visible. Note sinuosity and flow diversity.**  
(Source: EA RWRS fact sheets combined)

Several gravel glides have been created along the reach by importing material from a local source. The glide locations were selected in areas with appropriate channel dimensions to ensure all silt and sand material remains mobile under a wide range of flows. Woody debris and pinned willows were used to help improve silted gravel beds. By constricting the flow in this way has ensured fine sediments remain on the move and the gravels remain exposed, providing spawning habitat for trout and habitat for a range of invertebrates which depend on clean gravel substrate.

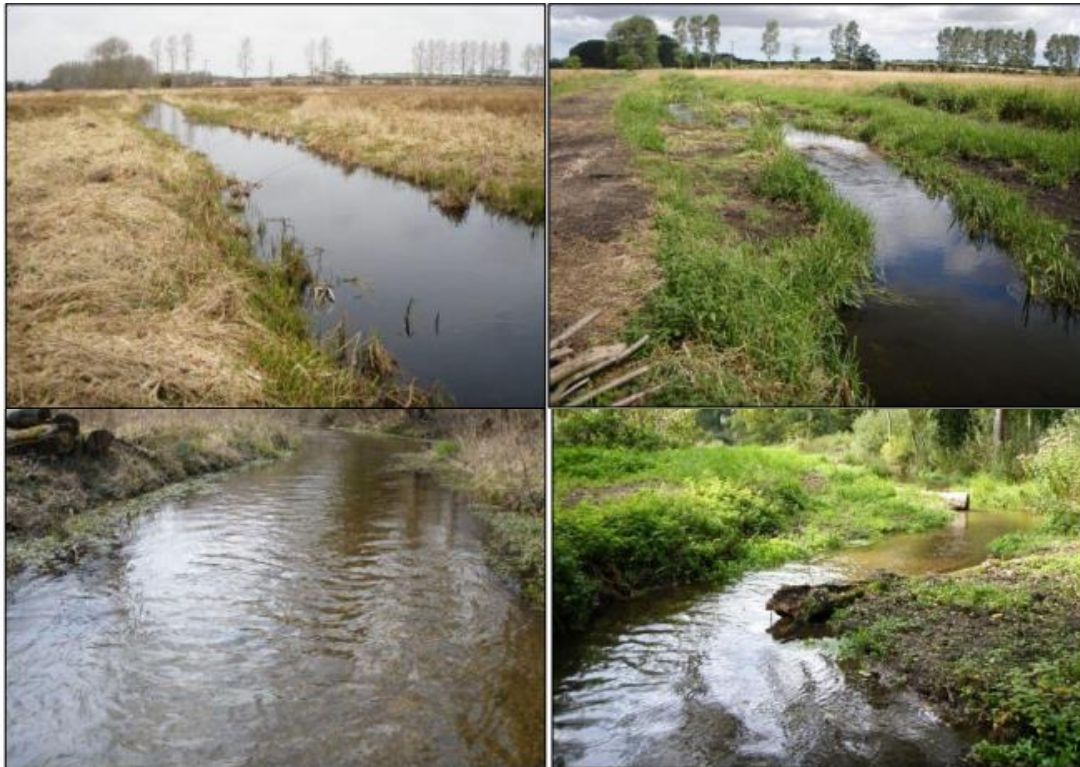
**Figure 5-51. Left-hand images display the River Tat pre-restoration, and the right-hand images display the same reaches post-restoration. Note the increase in flow diversity and constriction of the channel in both locations. (Source: EA RWRS fact sheets combined)**

Additionally, several floodplain drainage ditches have been reconnected to the main river channel. These provide both refuge areas in flood events and increase the diversity of habitat available to fish

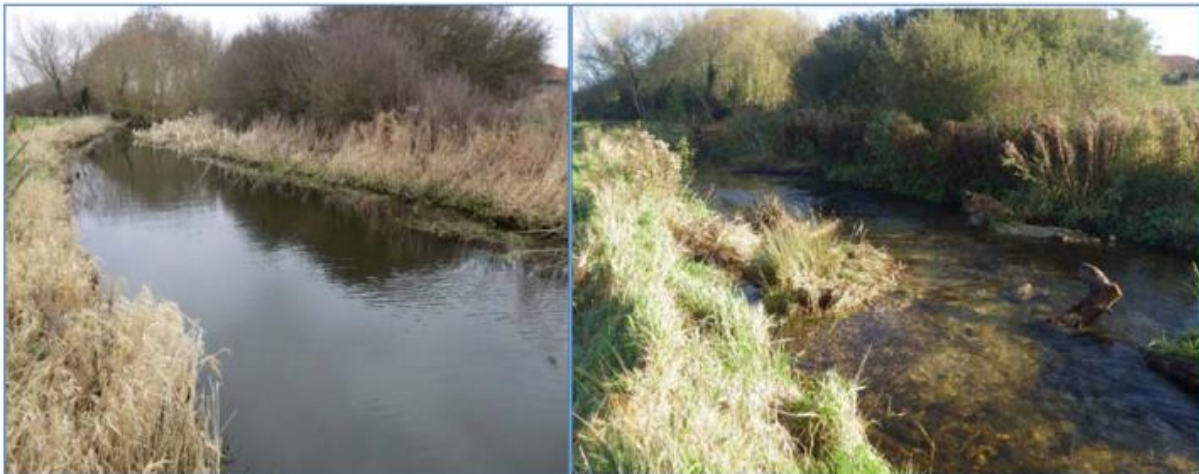
Figure 5-67. Before and after restoration photographs (Source: EA RWRS fact sheets combined)

The scheme utilised a number of techniques including importing gravel to create glides, redistribution of the gravel bed to create glides and pools, construction of berms to narrow the channel and improve sinuosity, installation of woody material features and the reinstatement of two meander loops.
